EVALUATION REPORT OF LIQUID PIPELINE CONSTRUCTION

Inspection Report		Post Inspection Memorandum	
Inspector/Submit Date: Southwest Region		Inspector/Submit Date:	
		Peer Review/Date:	
		Director Approval/Date:	
POST INSPECTION MEMORANDUM (PIM)			
Name of Operator:	TransCanada Oil Pipeline Operations Inc.		OPID #: 32334
Name of Unit(s):	Keystone Gulf Coast Pipeline North / Keystone Gulf Coast Pipeline South		Unit #(s): 74979,83245
Records Location:	Transcanada Sharepoint site, Contractor offices, Transcanada Office		Activity # 135840 & 140666
Unit Type & Commodity:	Interstate Liquids (Crude)		
Inspection Type:	Construction		Inspection Date(s): 2011-2014
PHMSA Representative(s):	Clint Stephens /Jon Manning /James Arnold / Noah Matthews/Barry Small/ Bill Lowry/ Basim Bacenty/ Joseph Elmer/ David Eng/ John Pepper	AFO Days:	165.9

Transcanada Keystone Pipeline LP, notified PHMSA in a letter dated September 30, 2011 of the construction of the Keystone Gulf Coast Pipeline starting in Q1 of 2012. The construction of the Keystone began in 2011 and was commissioned in 2014. Since 2011 until the commissioning of the pipeline on January 22, 2014, PHMSA, Southwest Region conducted onsite inspec

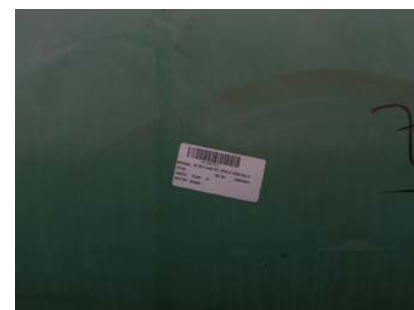
Labels were checked in the field for damage or non-readable labels. See Figure 7. All components inspected were consistent with the pressure rating and in accordance with the established MOP.

Figure 7: Pipe Label

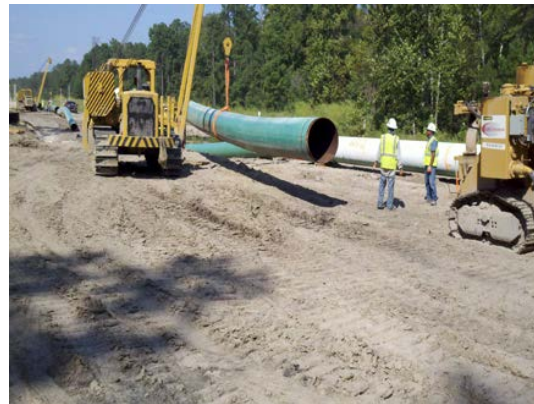
Field pipe bends were observed by PHMSA during many field inspections. There were no wrinkle bends identified during these inspections. Pipe bends were performed by a bending machine which utilized an internal bending mandrel to achieve smooth and undistorted bends. PHMSA witnessed pipe bending activities which are shown in Figures 11 and 12. There was no mechanical damage identified during the pipe bending activities.

Figure 12: Bent Pipe

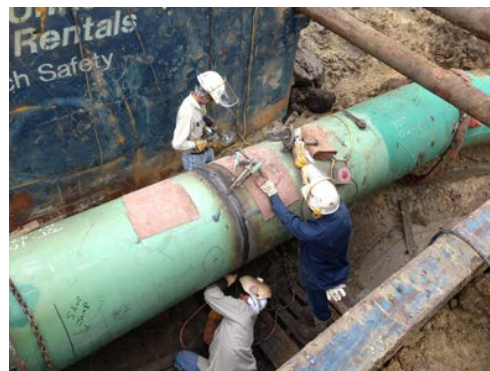
During the PHMSA field inspections and welding qualifications review, there were two issues and concern identified by PHMSA. One concern raised was the high welding repair/rejection rate. From the start of welding, TransCanada experienced a high weld rejection rate on Spread 3. A second issue identified by PHMSA was that TransCanada failed to properly qualify welders on Spread 3 of the

Figure 22: Manual Welding Set up

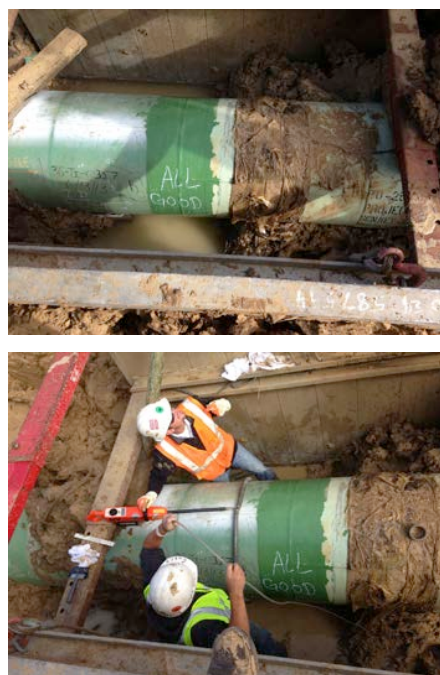
TransCanada conducted a Direct Current Voltage Gradient (DCVG) survey of the entire Keystone Gulf Coast Pipeline to check for any coating damage. After the survey, TransCanada submitted the findings of any coating damage found along with repairs made on anomalies. There were a total of 127 anomalies on Spread 1, 83 anomalies on Spread 2, and 43 anomalies on Spread 3 found by the survey. None of the anomalies found met the repair criteria of 35% IR, the highest was 32%. TransCanada performed verification digs on the highest IR readings on all three spreads to assure accuracy of the DCVG Survey. They made 8 digs in Spread 1, 8 digs in Spread 2, and 4 digs in Spread 3 and made repairs accordingly. The reports were reviewed by PHMSA to assure compliance with their procedures and the regulations. PHMSA conducted field inspections to verify dig sites identified by the DCVG survey. Figures 25 and 26 depict two locations identified by the DCVG survey during a PHMSA field inspection.

Figure 25 and 26: DCVG dig site (recoated)

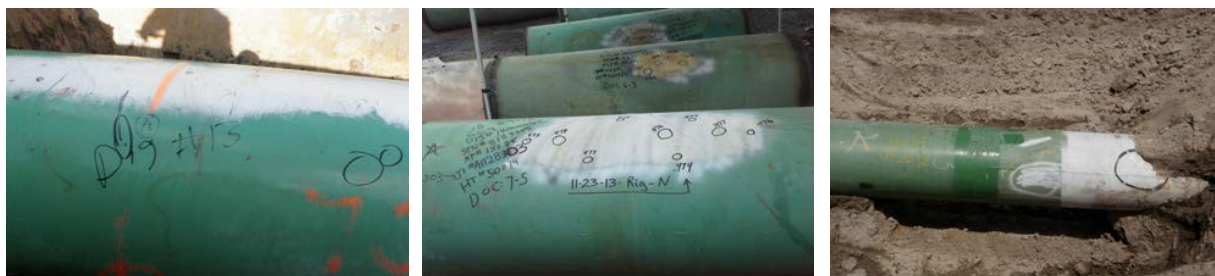
TransCanada did not assure that its Keystone Pipeline was installed in the ditch in a manner that minimizes the possibility of damage to the pipe. The deformation tool identified dents on the pipe that appear to be caused by secondary stresses on the pipe. The ILI tool identified a total of 421 anomalies which required investigation per the specifications. There were a total of 236 dents, 56 pipe ovality and 129 anomalies with both dent and ovality. TransCanada verified the locations by excavating the anomalies and made repairs in accordance with their specifications. After excavating and examining the anomalies, there were a total of 350 anomalies within the specifications, 37 anomalies which required being cut-out and 34 anomalies with no indications of a dent or ovality. During the field inspections, PHMSA witnessed and examined anomaly investigations being conducted by TransCanada due to the results of the deformation tool run. In this report you can see examples of the types of dents identified with the inspection tool. Each dent was examined

Figure 32, 33, 34 Examples of dents found with inspection tool.

and measured and nondestructively tested with ultrasound testing equipment to check for cracks. All dents were either cutout or were below the repair criteria. Several anomaly reports stated that foam pillows and rocky terrain were present at the dig sites which may

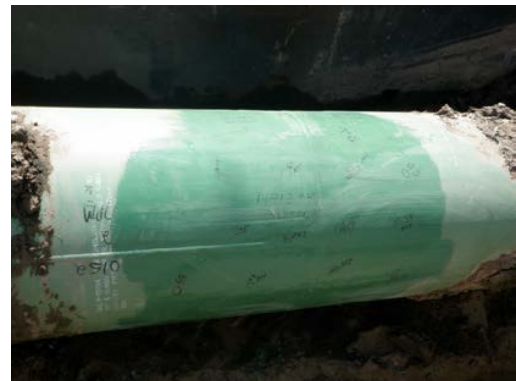
TransCanada did not follow its written specification, specifically, protecting existing coating from damage due to welding. In an email dated June 7, 2013, TransCanada notified PHMSA of a non-conformance issue involving coating damage on Spread 3 which TransCanada was in the process of investigating. The problem only occurred in Spread 3 due to the manual welding process with stick rods being utilized. Manual welding was used mainly due to the terrain and the number of water crossings. Spread 1 and 2 utilized the semiautomatic welding process. There were several locations in which the contractor did not follow TransCanada's coating specifications. Specifically, weld blankets were not being utilized to protect the existing coating on the pipe to prevent weld splatter from damaging the coating. TransCanada's specification TES-WELD-PL- US Welding of Pipelines and Tie-ins, Section 8.11 states that "existing coatings on piping shall be protected to minimize damage that may result from the welding operations" which was not being followed by the contractor. After investigating 23 suspected locations, TransCanada confirmed the coating damage and repaired the coating per the specifications.

During the field inspections, PHMSA observed several girth welds had coating damage due to weld splatter. Figure 35 shows the coating repair on the girth welds due to damage of the weld

Figure 35: Repair of coating due to weld splatter.

splatter. The coating repair was made after the pipeline was exposed and examined. The pipe was coated and backfilled per the specifications. There were a total of 130 identified locations excavated in which TransCanada examined for damage and made repairs were necessary. All discovered damage was inspected and repaired to original specification criteria.

TransCanada responded to the Warning Letter and assured that they were taking steps to enhance its design, specifications and inspection practices, by conducting a thorough review of their inspection practices, design, and construction specifications, and would implement changes to try to reduce the number of inspection digs that are required after the pipeline has been backfilled going forward, which included, but not limited to restricting the use of foam pillows, increased use of bedding material in rocky or hard pan conditions, and specifying the minimum size of weld splatter protection devices.
