# Inspection Report

## Chief's Order No. 2015-29

### Division of Oil and Gas Resources Management (DOGRM)

**Site Name:** PETTA Cambridge Facility

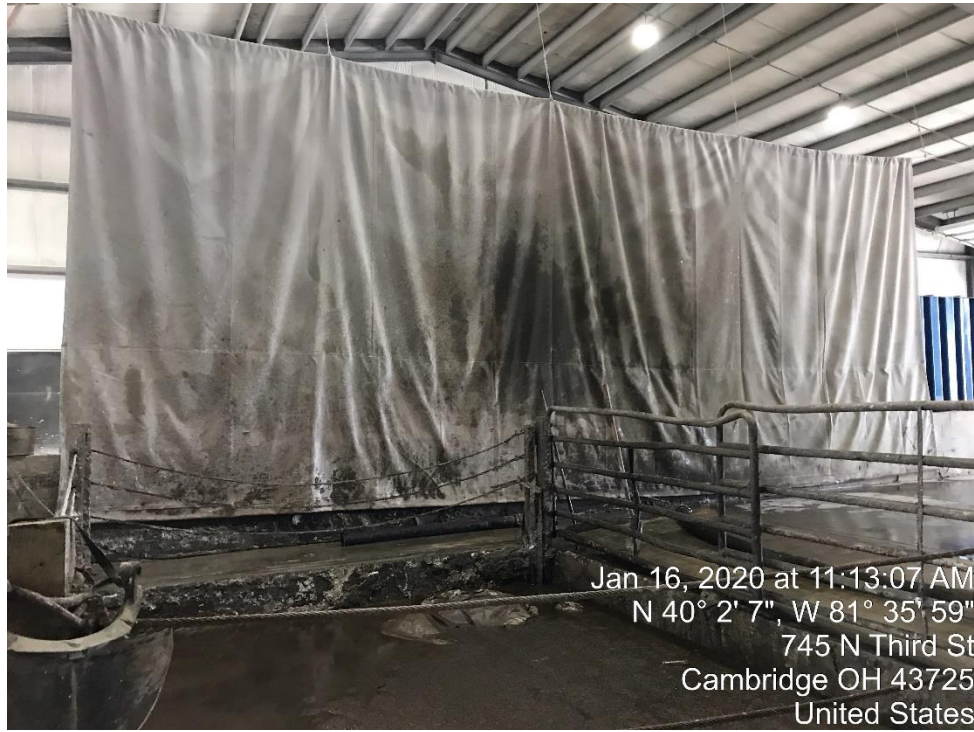
- Regarding the industrial waste processing, Mr. Applegate stated that a separate track hoe had been purchased. A sign was located above the northernmost bay indicating the industrial waste segregation. No construction had started on the outside tank storage for industrial waste processing. A frac tank was located within the industrial waste processing side, and no hoses or piping were noted going over to the interior oil and gas tank storage area.

**Industrial processing area curtain**

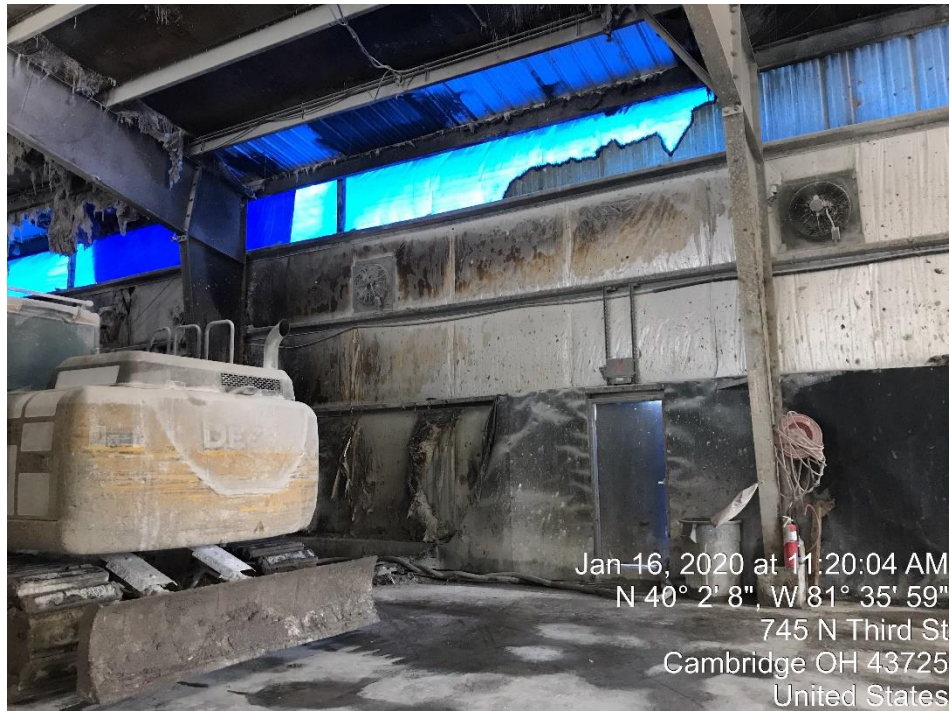
- A fire involving waste and hot lime had occurred at the facility on 12/21/2019. Damage had occurred to the building and a track hoe. DOGRM discussed the damage that had occurred and operational changes to prevent future incidents.

**Building damage from fire**

- **Please provide Mr. Petta's contact phone number.**
- Provide operating procedures, changes in procedures, and/or other actions to be taken to prevent potential ignition of the lime and waste in the future.

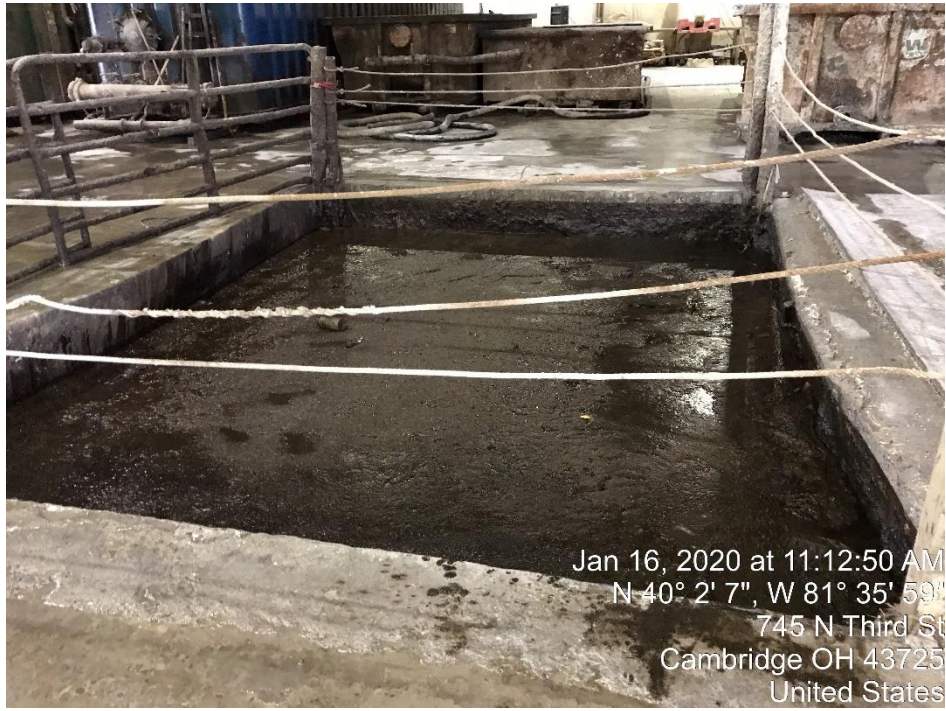
**Pit #1**

- The two oil and gas waste mixing pits had approximately 12” of freeboard and were filled with flowable sludge. The track hoe was not operating during the visit. A frac tank was stored to the east of the pits and was used to store overflow of waste. The centrifuge had not been operational for around a month and had recently been repaired.

- Continue efforts to prevent waste accumulations on the floor of the building, outside of primary containment.
- Repair the steel aprons of the primary containment pits. Provide a means to prevent wastes and liquids from being washed into the secondary containment pits.
