TransCanada's Keystone XL Southern Segment:

Construction Problems Raise Questions About the Integrity of the Pipeline

November 2013

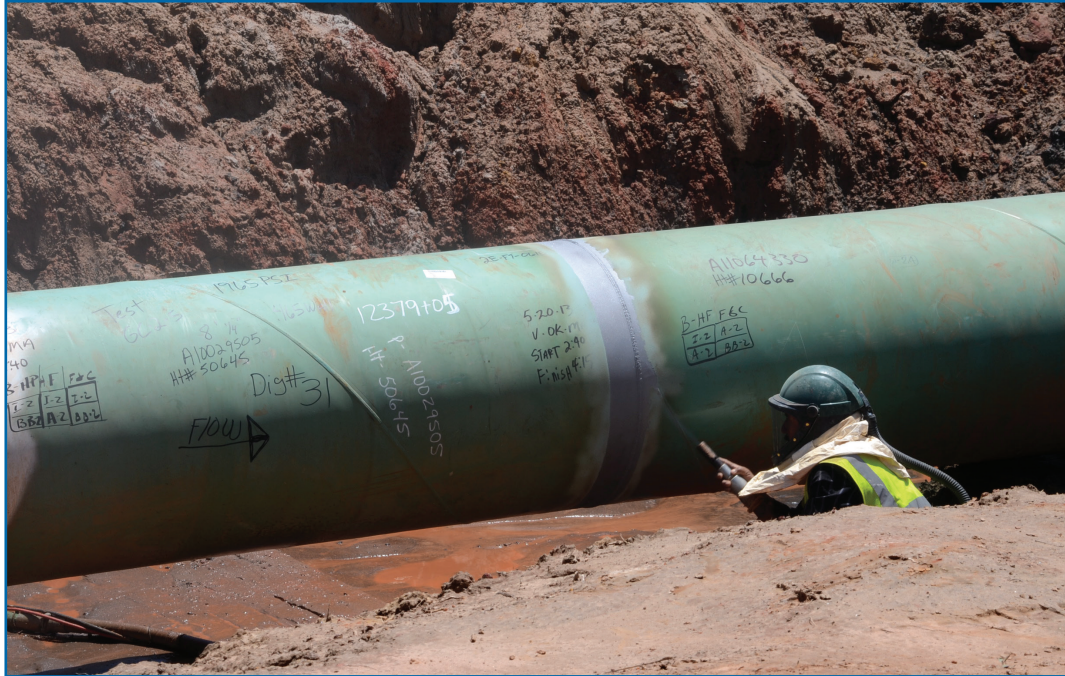
Workers in a trench are finishing the new replacement of pipe on a landowner's property.

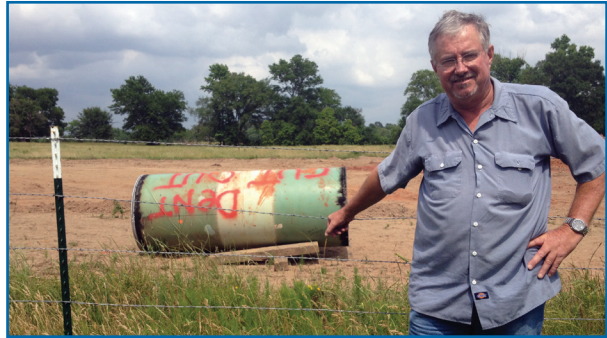
David Whitley stands near his fence with a short piece of removed pipe marked "Dent" and "Cut Out."

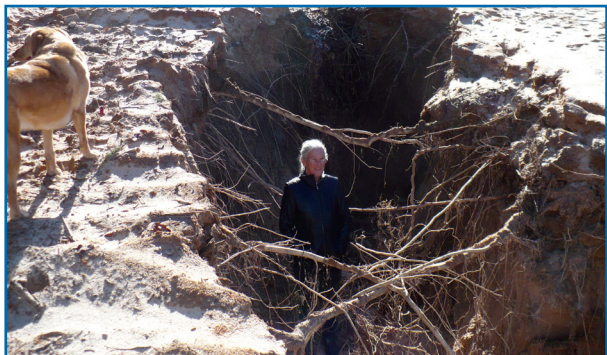
Eleanor Fairchild stands in an erosion area adjacent to a wetland after pipeline construction on her property.

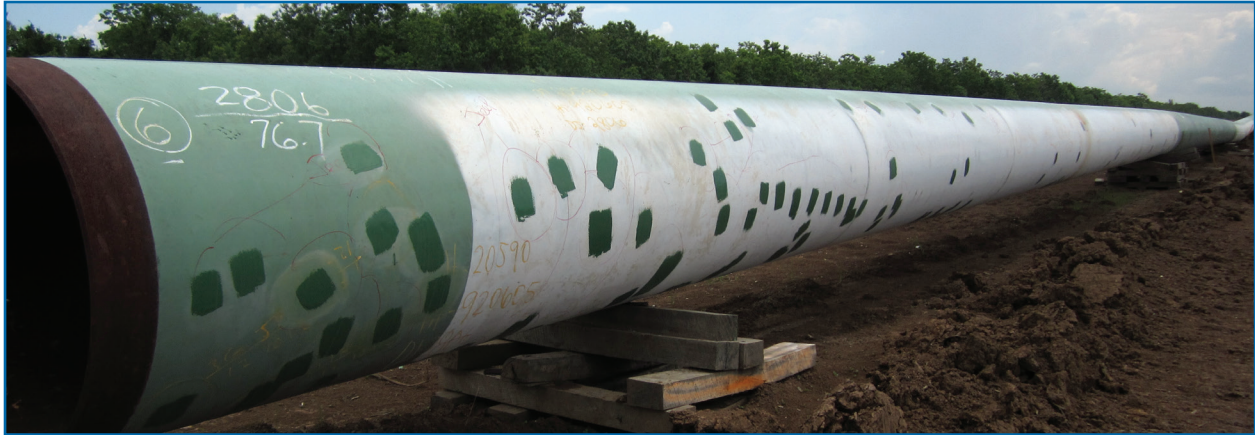
Dark green areas show extensive applications of field coating, or patching, over damaged areas on the pipe before it is lowered into the trench during pipeline construction. The code required reasonable care in handling of the pipe to avoid damage to this very tough coating.

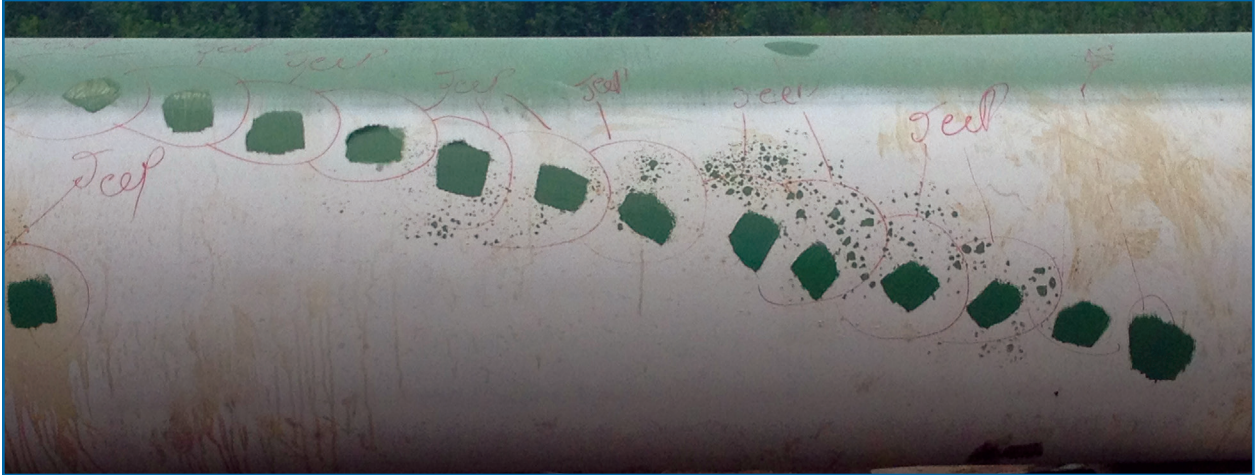
Patches have been applied to cover “holidays,” or holes and pipeline damage. Some of the patches are peeling before the pipeline is to be buried in the ground.

Holes or damage to the original coating to the extent shown above indicates rough handling of the pipe. The damage, called “holidays” by the industry, can be points of discontinuity (such as holes and scrapes) where the pipeline surface is exposed to the environment, which can promote corrosion of the pipeline.³⁷

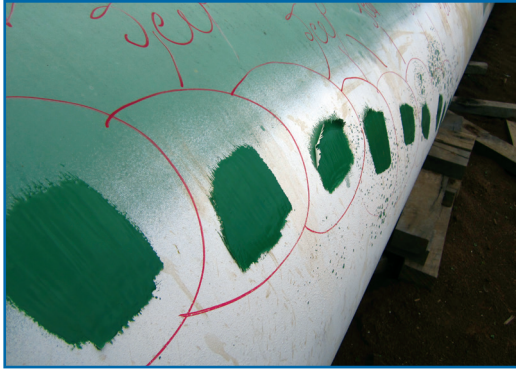
Close-up pictures of the repair patches, showing that the apparent lack of surface preparation before application of patching material has resulted in repair patches not adhering to the pipe. Pictured above some of the patches in this photo is the word "Jeep." A jeep is an electric tool used to detect pipeline abnormalities or holes.

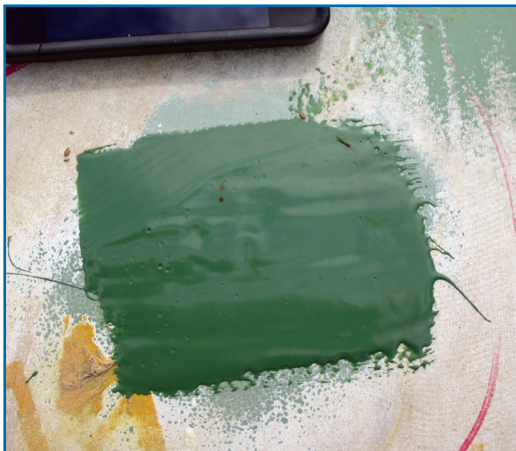
Tiny holes in the patching indicate uneven application of field coating, which can partially expose the area that had been repaired.

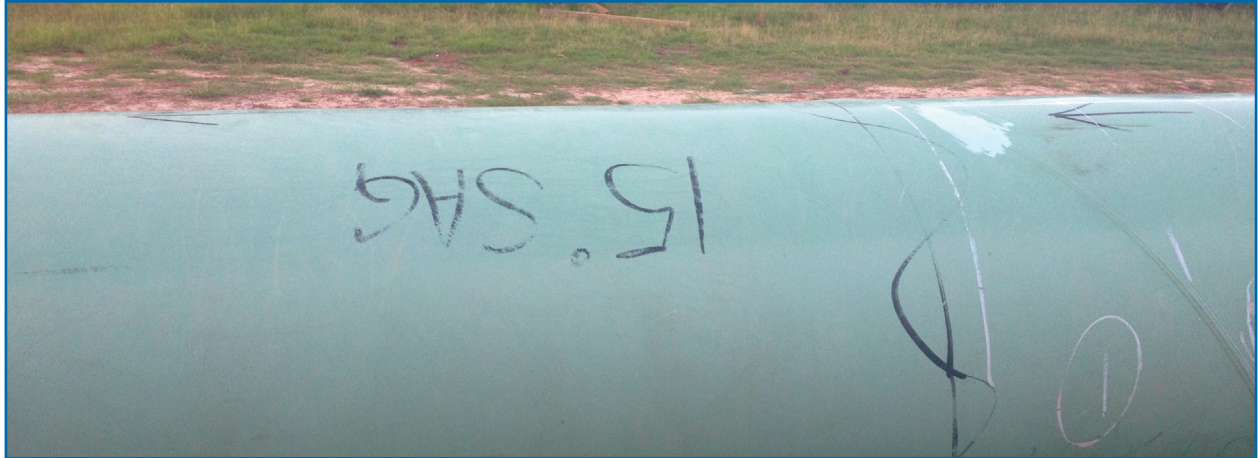
East Texas residents discovered sags in various locations where pipe had been excavated.⁴⁴ Unintentional sags due to pipe unsupported during lowering into a trench, or while pipe sections are welded together, can result in permanent bends and can allow buckling to occur. This ultimately can lead to cracks and ruptures. The degree of sag was indicated on the excavated sections. In this case, the sag of the pictured section above was 15 degrees, and the section was removed from the trench.

A pipeline section that is cut out evidently due to the excessive sag or bending of the pipe.

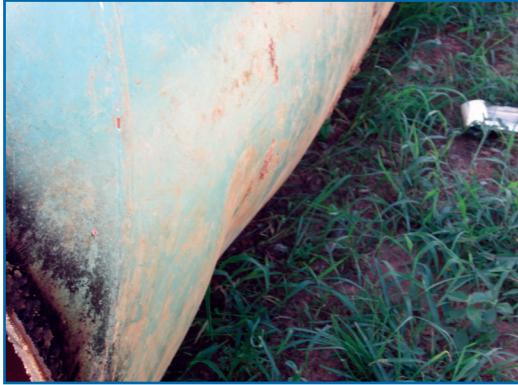
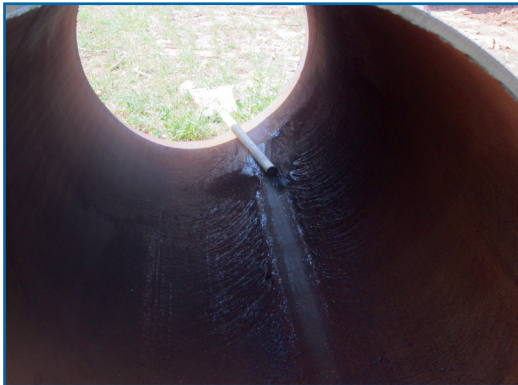
The two shots are of the exterior and interior of a massive dent from the inside of a pipe section near Jacksonville, Texas.

Dents were among the anomalies identified in new pipe excavated along the pipeline route. The code currently allows only for nominal mechanical deformation.⁴⁵ Some dents that were observed were as deep as that of a brick. Dents most often occur when pipe is placed in a trench where rocks or debris are present.⁴⁶ The code of construction requires pipe to be laid flat on the bottom of the trench and firmly supported. Once the trench is ready to be backfilled with soil to close the ditch, any remaining debris underlying the pipe can dent the pipe due to the downward weight and pressure of the compacted soil and backfilling equipment.⁴⁷

Dents can provide major areas of stress concentration on a pipeline, since cracks will often develop over time where the creases of dents occur, fostering the probability of a leak or rupture where those stress points are located on the pipe, especially if dents occur on welds.⁴⁸ It is a qualified inspector's responsibility to ensure that the construction contractor does not lay or cover pipe in a ditch until the ditch can provide smooth, firm underlying support for the pipeline, as mandated by the quality assurance requirements of the construction code.⁴⁹ Fuel Fix photos published in late October, along with photos from the Houston Chronicle, indicate that the ditching inspector did not ensure that rocks were removed from the trench before lowering the pipe into the ditch.⁵⁰ Aerial pictures of an active excavation site showed that rocks were removed from under a portion of the pipeline that was excavated.

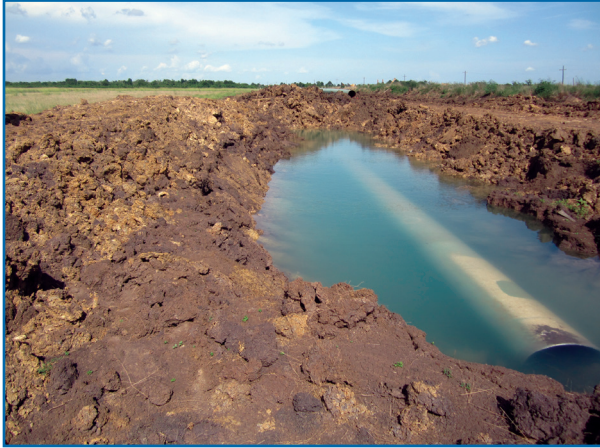
The pipe is not level in the ditch. The trench has collapsed around it on a construction site near Beaumont.

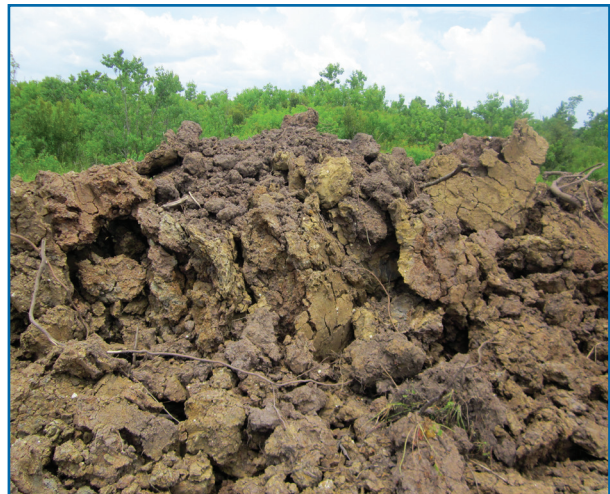
The code of construction requires good right-of-way reclamation practices for ground disturbed during construction.⁵⁵ Good construction practice requires that excavated topsoil be kept separate from the subsurface materials, so that when the pipe is finally covered up, the arable topsoil can be once again placed atop the ground's surface to ensure plant and crop growth.⁵⁶ On David Holland's property, and on other properties, the darker topsoil appears to have been comingled with the lighter sterile subsurface clays. If the arable and substrate soil shown in this picture is used in this mixed form to cover the trench, the farmer or landowner will have difficulties growing crops, pasture or other plant life in the same way as before the ground was disturbed. David Whitley has complained that the soil where the pipeline had been constructed will not grow grass as expected for grazing purposes. Instead, only plants of no agricultural value can grow there. Many other landowners have reported a similar problem.

The good black topsoil and the underlying yellow substrate are comingled on this landowner's property near Beaumont. When replaced over the trench, this mix will not support valued agricultural plant life.

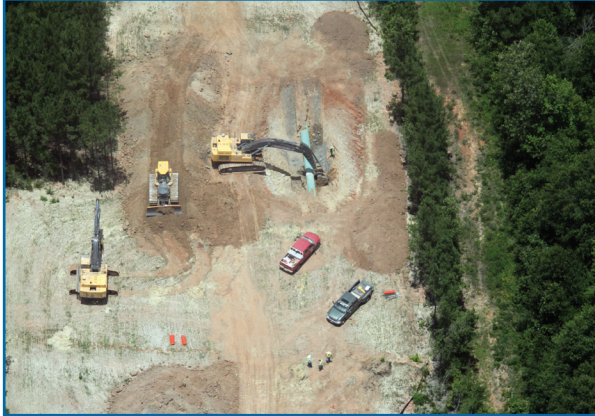
In filling the trench on this construction site near Lufkin, the trackhoe's bucket is pulling soil near the pipe, affording the possibility for the bucket to hit the line.

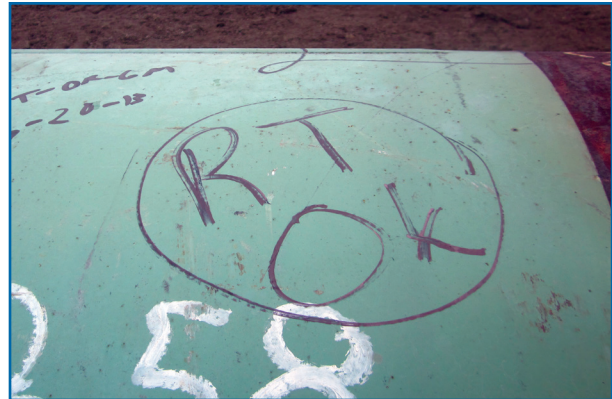
The markings in the picture, and observed frequently in the field, indicate that RT was used to inspect the two new welds per each replaced pipeline section. RT is a less accurate technology. It is a process similar to taking a medical X-ray.⁶⁴ Once the welded pipe is in the ground, external examination is required so an X-ray is then taken from outside the pipe. With this process, the source used for the X-ray will expose both the top and bottom layers of pipe, and thus the weld can be twice the distance from the film, which significantly reduces radiographic quality. The radiography examiner will try to make a judgment on the safety of the welds based on this X-ray, which loses some clarity since it

Proof that radiography testing (RT) was used during construction. This notation was seen on pipe on multiple East Texas properties.

is taken through multiple layers of steel. Radiographic technicians prefer to avoid taking these exposures because the results can be quite hard to interpret and cracks are missed.

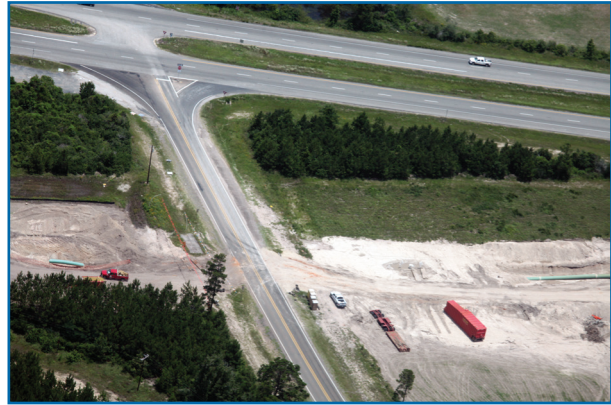
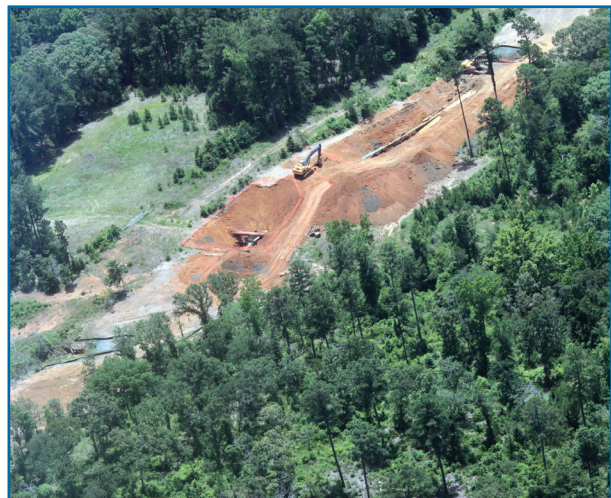
Top: Typical view of a remediation showing extensive pipe exposed near the city of Corrigan. Above: Area near Jacksonville showing a transition area at the bottom of a hill near a watercourse, where typically two thicknesses of pipe are tied, requiring technical welding skills.
