EVALUATION REPORT OF LIQUID PIPELINE CONSTRUCTION

Transcanada Keystone Pipeline LP, notified PHMSA in a letter dated September 30, 2011 of the construction of the Keystone Gulf Coast Pipeline starting in Q1 of 2012. The construction of the Keystone began in 2011 and was commissioned in 2014. Since 2011 until the commissioning of the pipeline on January 22, 2014, PHMSA, Southwest Region conducted onsite inspections and reviewed documents which include construction specifications, construction inspection reports, welding qualifications, etc., submitted by Transcanada. A total of 165.9 AFO days and 53.35 non-AFO days were spent on the Transcanada construction project.

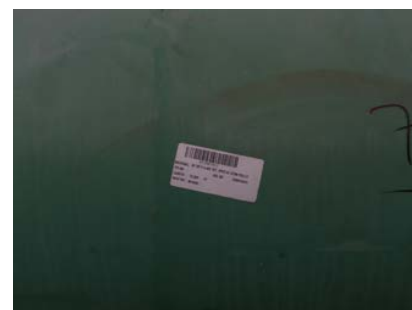
Labels were checked in the field for damage or non-readable labels. See Figure 7. All components inspected were consistent with the pressure rating and in accordance with the established MOP.

Figure 7: Pipe Label

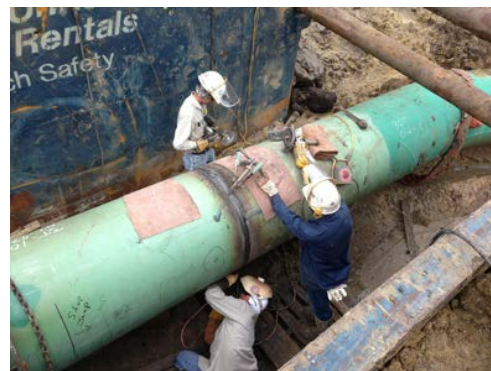
During the PHMSA field inspections and welding qualifications review, there were two issues and concern identified by PHMSA. One concern raised was the high welding repair/rejection rate. From the start of welding, TransCanada experienced a high weld rejection rate on Spread 3. A second issue identified by PHMSA was that TransCanada failed to properly qualify welders on Spread 3 of the

Figure 22: Manual Welding Set up

Keystone Gulf Coast Pipeline project. TransCanada performed welder qualifications using a welding procedure that had not been properly qualified and then allowed these welders to weld on a Part 195 regulated pipeline. These issues will be furthered discussed alter in the report.

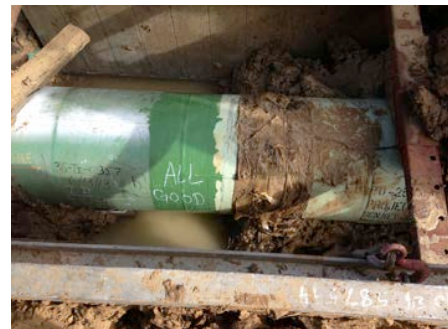
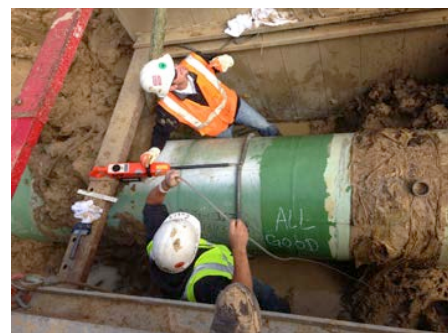
TransCanada conducted a Direct Current Voltage Gradient (DCVG) survey of the entire Keystone Gulf Coast Pipeline to check for any coating damage. After the survey, TransCanada submitted the findings of any coating damage found along with repairs made on anomalies. There were a total of 127 anomalies on Spread 1, 83 anomalies on Spread 2, and 43 anomalies on Spread 3 found by the survey. None of the anomalies found met the repair criteria of 35% IR, the highest was 32%. TransCanada performed verification digs on the highest IR readings on all three spreads to assure accuracy of the DCVG Survey. They made 8 digs in Spread 1, 8 digs in Spread 2, and 4 digs in Spread 3 and made repairs accordingly. The reports were reviewed by PHMSA to assure compliance with their procedures and the regulations. PHMSA conducted field inspections to verify dig sites identified by the DCVG survey. Figures 25 and 26 depict two locations identified by the DCVG survey during a PHMSA field inspection.

Figure 25 and 26: DCVG dig site (recoated)

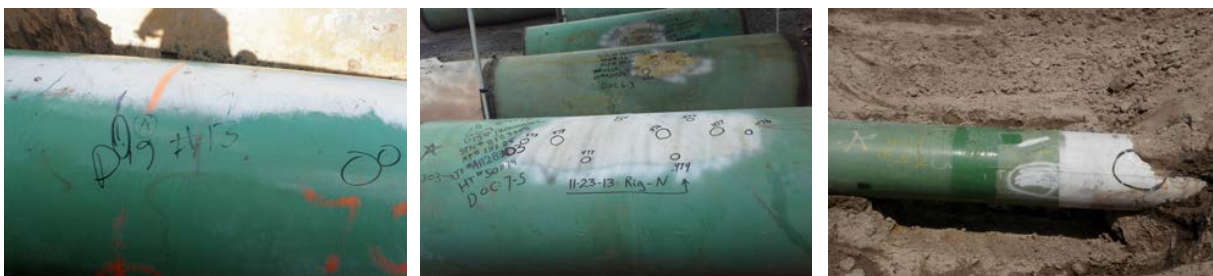
TransCanada did not assure that its Keystone Pipeline was installed in the ditch in a manner that minimizes the possibility of damage to the pipe. The deformation tool identified dents on the pipe that appear to be caused by secondary stresses on the pipe. The ILI tool identified a total of 421 anomalies which required investigation per the specifications. There were a total of 236 dents, 56 pipe ovality and 129 anomalies with both dent and ovality. TransCanada verified the locations by excavating the anomalies and made repairs in accordance with their specifications. After excavating and examining the anomalies, there were a total of 350 anomalies within the specifications, 37 anomalies which required being cut-out and 34 anomalies with no indications of a dent or ovality. During the field inspections, PHMSA witnessed and examined anomaly investigations being conducted by TransCanada due to the results of the deformation tool run. In this report you can see examples of the types of dents identified with the inspection tools. Each dent was examined

Figure 32, 33, 34 Examples of dents found with inspection tool.

and measured and nondestructively tested with ultrasound testing equipment to check for cracks. All dents were either cutout or were below the repair criteria. Several anomaly reports stated that foam pillows and rocky terrain were present at the dig sites which may

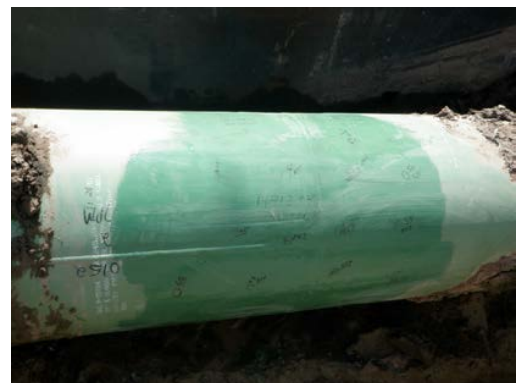
TransCanada did not follow its written specification, specifically, protecting existing coating from damage due to welding. In an email dated June 7, 2013, TransCanada notified PHMSA of a non-conformance issue involving coating damage on Spread 3 which TransCanada was in the process of investigating. The problem only occurred in Spread 3 due to the manual welding process with stick rods being utilized. Manual welding was used mainly due to the terrain and the number of water crossings. Spread 1 and 2 utilized the semiautomatic welding process. There were several locations in which the contractor did not follow TransCanada's coating specifications. Specifically, weld blankets were not being utilized to protect the existing coating on the pipe to prevent weld splatter from damaging the coating. TransCanada's specification TES-WELD-PL- US Welding of Pipelines and Tie-ins, Section 8.11 states that "existing coatings on piping shall be protected to minimize damage that may result from the welding operations" which was not being followed by the contractor. After investigating 23 suspected locations, TransCanada confirmed the coating damage and repaired the coating per the specifications.

During the field inspections, PHMSA observed several girth welds had coating damage due to weld splatter. Figure 35 shows the coating repair on the girth welds due to damage of the weld

Figure 35: Repair of coating due to weld splatter.

splatter. The coating repair was made after the pipeline was exposed and examined. The pipe was coated and backfilled per the specifications. There were a total of 130 identified locations excavated in which TransCanada examined for damage and made repairs were necessary. All discovered damage was inspected and repaired to original specification criteria.

TransCanada responded to the Warning Letter and assured that they were taking steps to enhance its design, specifications and inspection practices, by conducting a thorough review of their inspection practices, design, and construction specifications, and would implement changes to try to reduce the number of inspection digs that are required after the pipeline has been backfilled going forward, which included, but not limited to restricting the use of foam pillows, increased use of bedding material in rocky or hard pan conditions, and specifying the minimum size of weld splatter protection devices.
