**Study of Root Cause and Contributing Factors
Keystone Pipeline
Corrosion Anomaly Investigation**

Final Report

2/13/2013

TransCanada

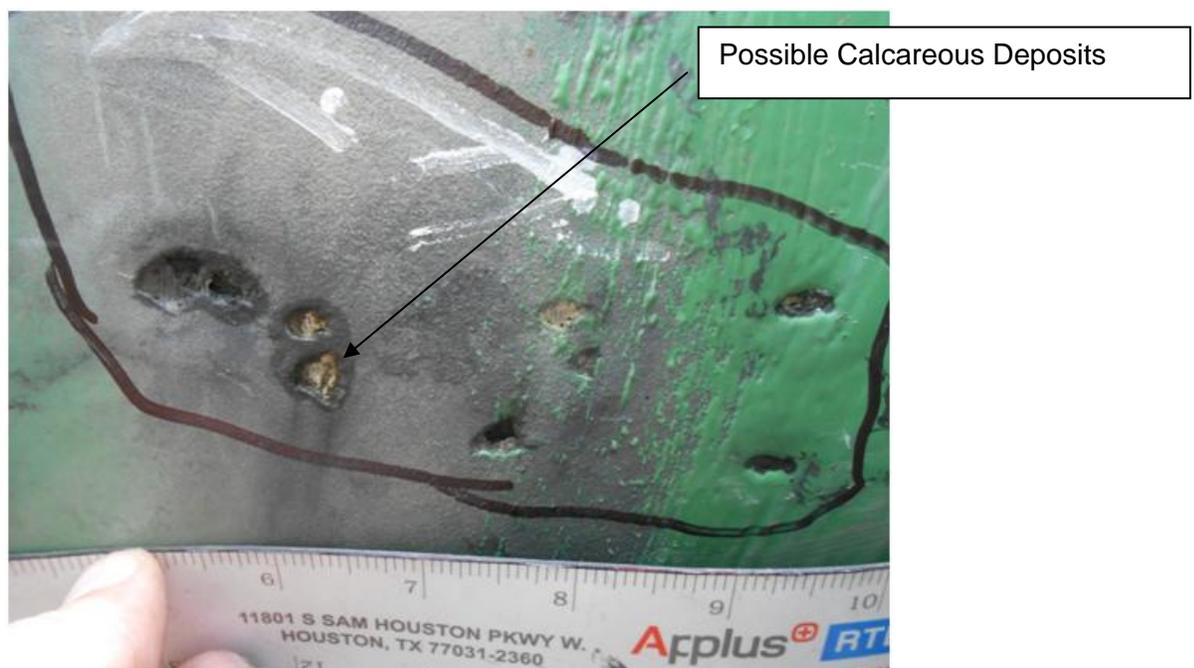
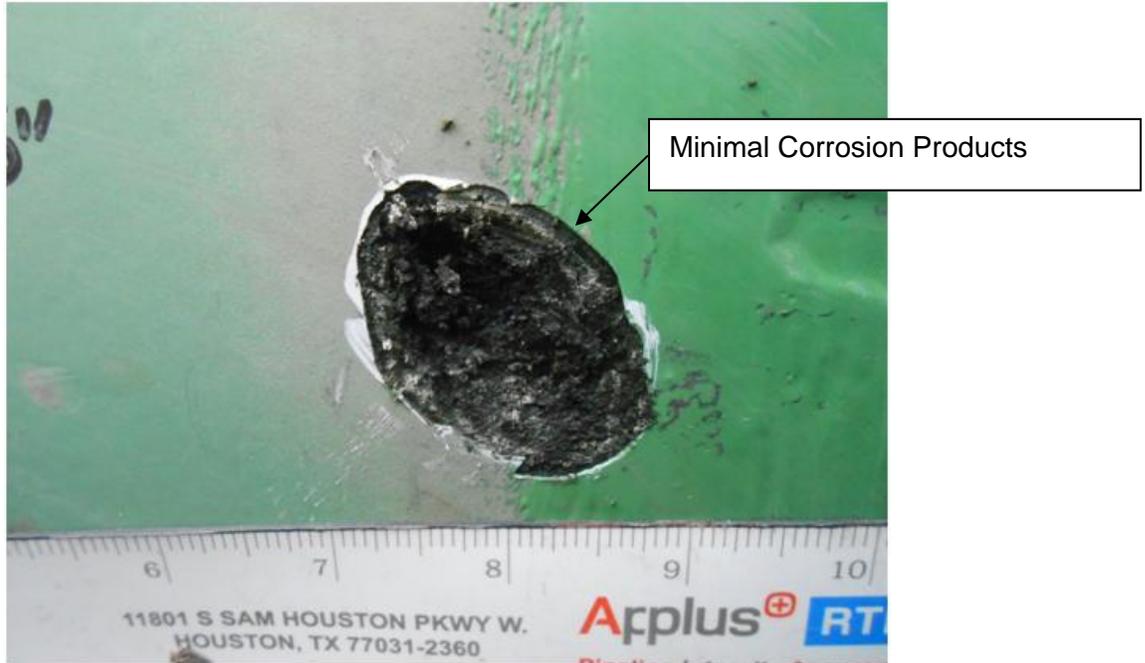
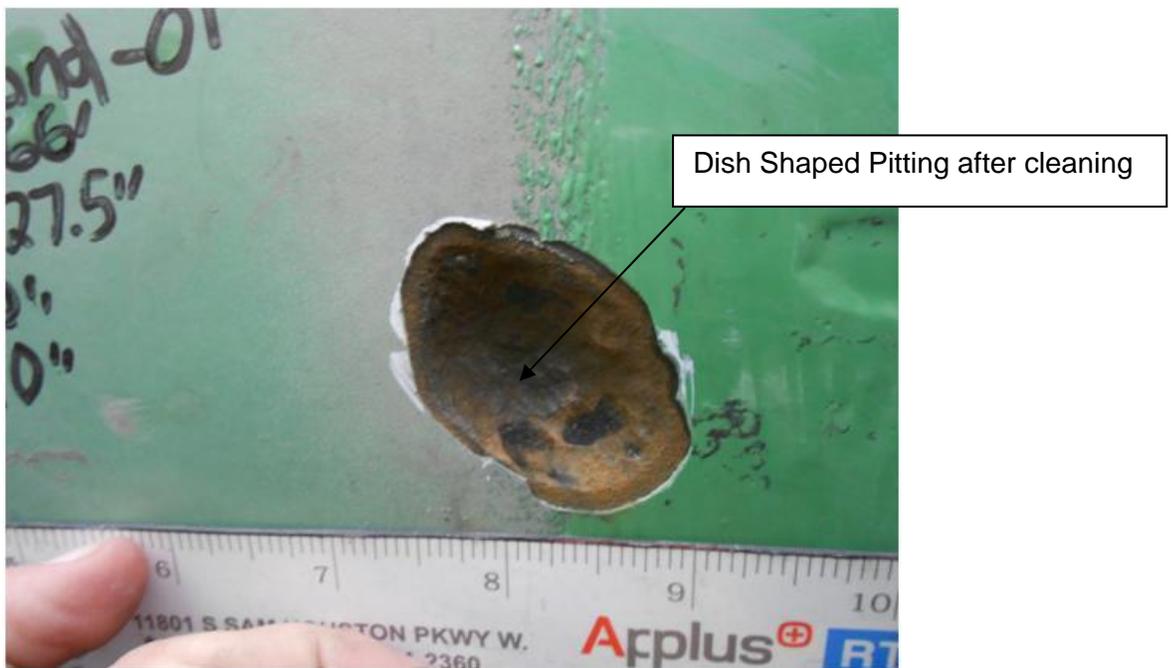
This anomaly was classified as an immediate indication and was found to have six (6) anomalies caused by external corrosion with a peak depth of corrosion reported to be 96.8%. Approximately 9.0 feet of pipe was exposed from Station 597+20.0 to 597+29.0. The deepest corrosion anomaly is dish shaped and developed in an overlap area of a liquid epoxy repair. The reported CP potentials documented in the RTD Dig report ranged from -0.685 v to -0.710 v (CSE). Soil pH was reported to be between 5.5 and 6.0. The corrosion anomalies can be seen in Figures 9, 10 and 11.

Figure 9. MP 995.95 External Corrosion Pitting

Figure 10. MP 995.95 –External Corrosion Pitting

Figure 11. MP 995.95 –External Corrosion Pitting

The accelerated rate of corrosion and the observed corrosion morphology along with an absence of tubercles is consistent with D-C Stray Current Corrosion. The possibility of calcareous deposits in some pits that appear in Figure 9 suggest that CP current may have

reached this site after corrosion initiated perhaps due to modifications to the CP system operating characteristics.

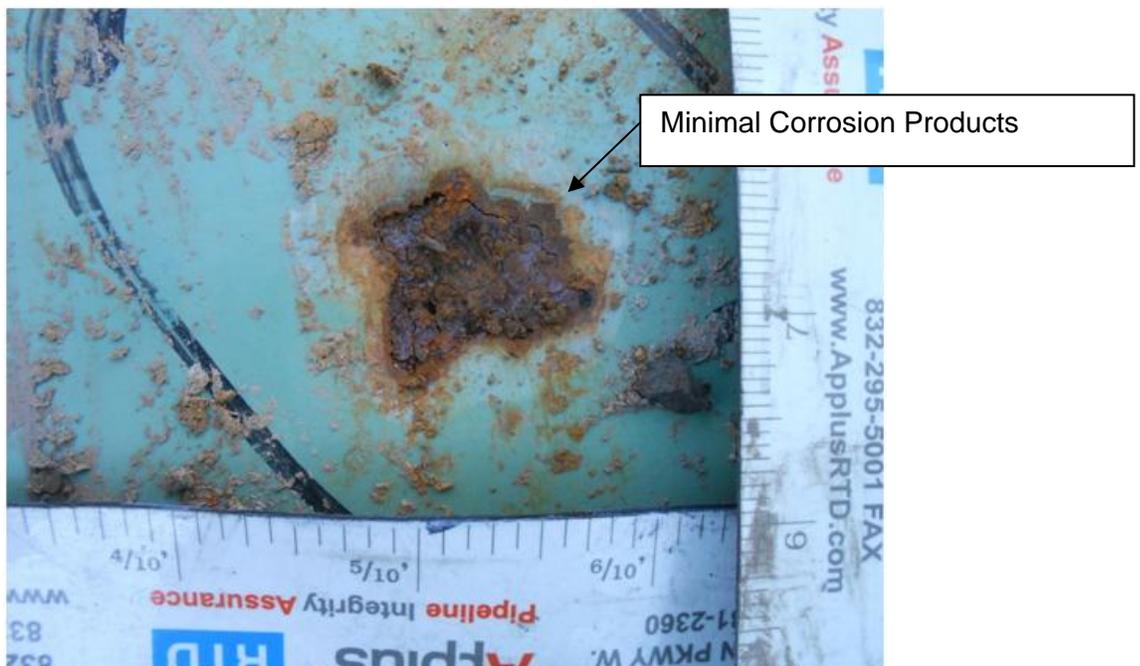
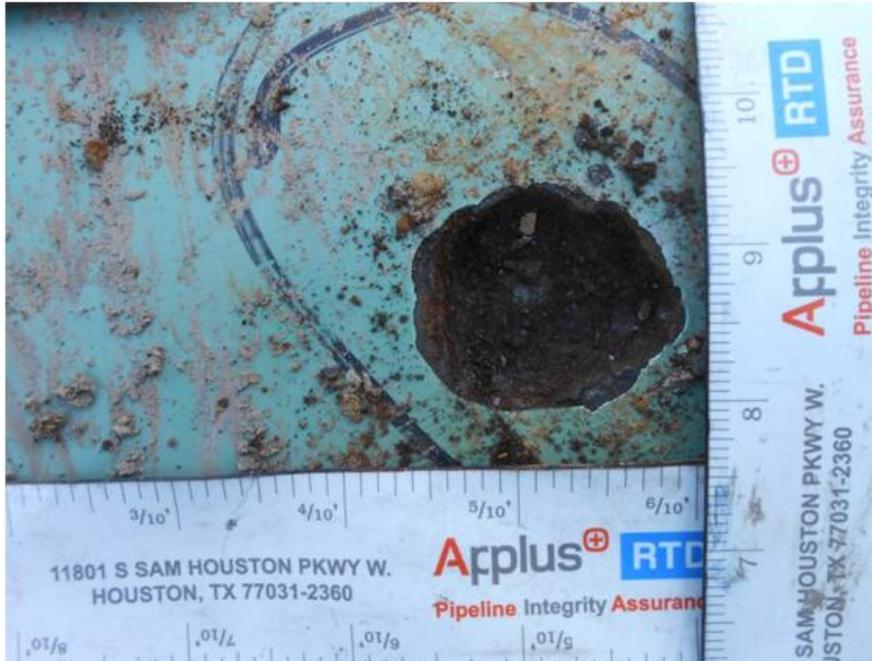
This anomaly was classified as an immediate indication and was found to have one (1) anomaly caused by external corrosion with a peak depth of corrosion reported to be 73.9%. Approximately 9.5 feet of pipe was exposed from Station 617+30.5 to 617+40.0. The corrosion anomaly is dish shaped. The reported CP potentials documented in the RTD Dig report ranged from -0.660 v to -0.840 v (CSE). Soil pH was reported to be between 5.5 and 6.0. The corrosion anomalies can be seen in Figures 12 and 13.

Figure 12. MP 996.33 –External Corrosion Pitting

Figure 13. MP 996.33 –External Corrosion Pitting

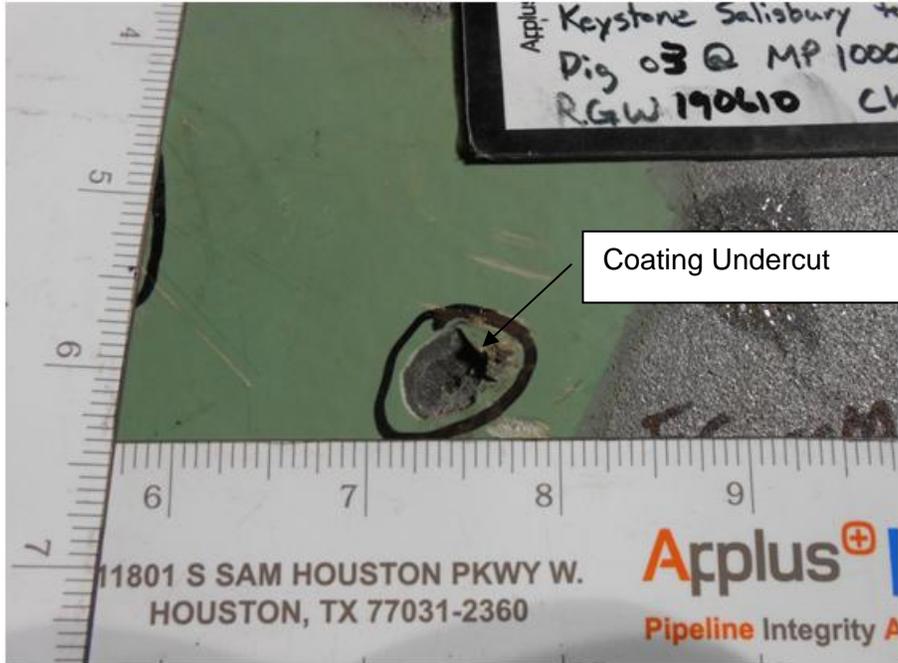
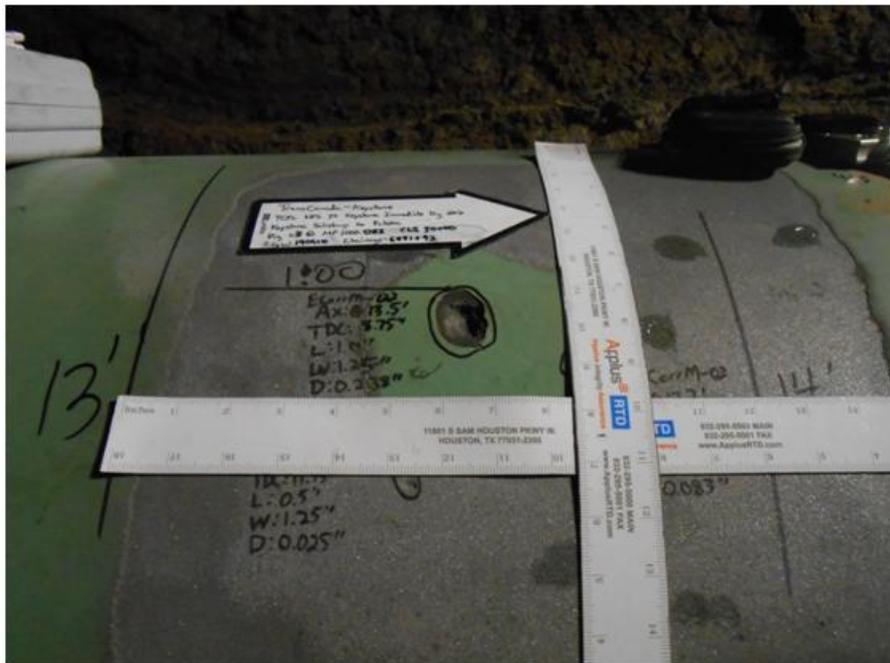
This anomaly was classified as an immediate indication and was found to have three (3) anomalies caused by external corrosion with a peak depth of corrosion reported to be 59.9%. Approximately 11.0 feet of pipe was exposed from Station 815+72.0 to 815+83.0. The corrosion anomaly is dish shaped. The reported CP potentials documented in the RTD Dig report ranged from -0.846 v to -0.870 v (CSE). Soil pH was reported to be 6.0. The corrosion anomalies can be seen in Figures 14 and 15.

Figure 14. MP 1000.08 –External Corrosion Pitting

Figure 15. MP 1000.08 –External Corrosion Pitting

The accelerated rate of corrosion and the observed corrosion morphology along with undercutting of the FBE coating is consistent with D-C Stray Current Corrosion.

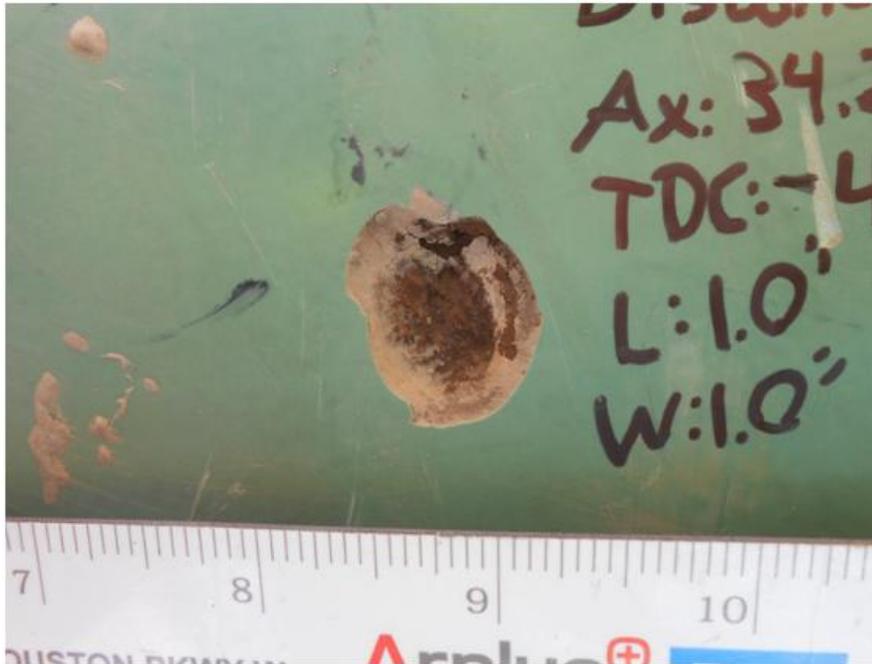
This anomaly was classified as an immediate indication and was found to have one (1) anomaly caused by external corrosion with a peak depth of corrosion reported to be 61.07%. Approximately 7.0 feet of pipe was exposed from Station 831+38.0 to 831+45.0. The corrosion anomaly is dish shaped. The reported CP potentials documented in the RTD Dig report ranged from -0.918 v to -0.935 v (CSE). Soil pH was reported to be 6.0. The corrosion anomaly can be seen in Figure 16.

Figure 16. MP 1000.38 –External Corrosion Pitting

The available photographic documentation is not sufficient to draw conclusion regarding root cause at this site.

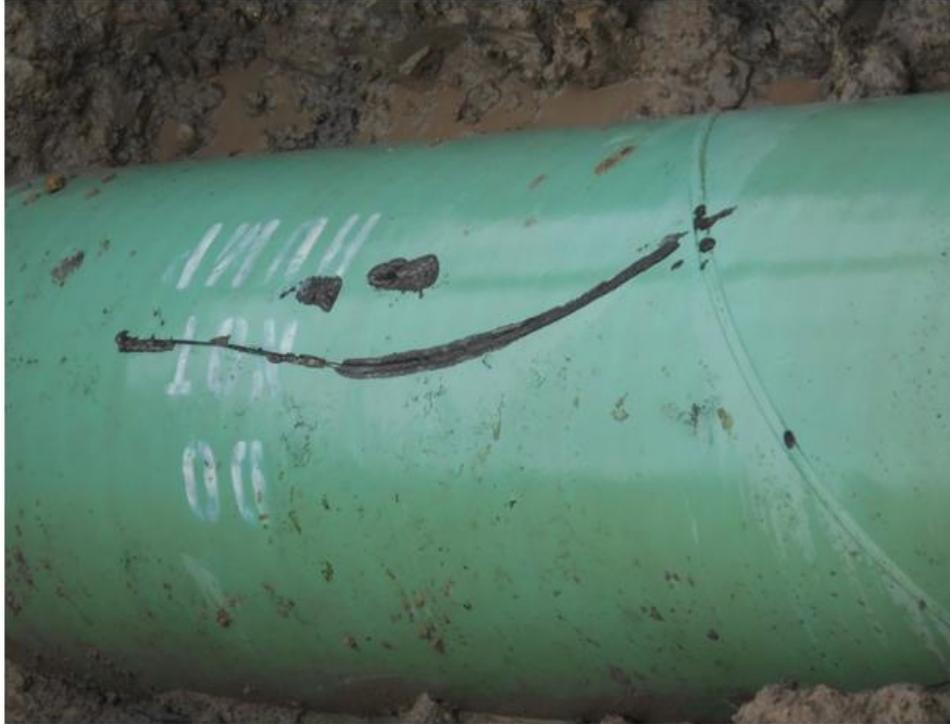
This anomaly was classified as a 180 day indication and was reported to have eight (8) anomalies caused by external corrosion with a peak depth of corrosion reported to be 55.6%. The pipe was exposed from Station 688+18.5 to 689+30.5. Corrosion anomalies appear to be axially oriented along a length of coating damage that appears to have been caused by construction damage or third party damage. Discrete dish shaped pitting was also detected in areas related to construction damage to the coating. The reported CP potentials documented in the RTD Dig report ranged from -0.918 v to -0.935 v (CSE). Soil pH was reported to be 6.0. The corrosion anomalies can be seen in Figures 17 and 18.

Figure 17. MP 997.67 –External Corrosion at Areas of Coating Damage

The observed corrosion has an accelerating factor, but the available photographic documentation is not sufficient to draw conclusion regarding root cause at this site.

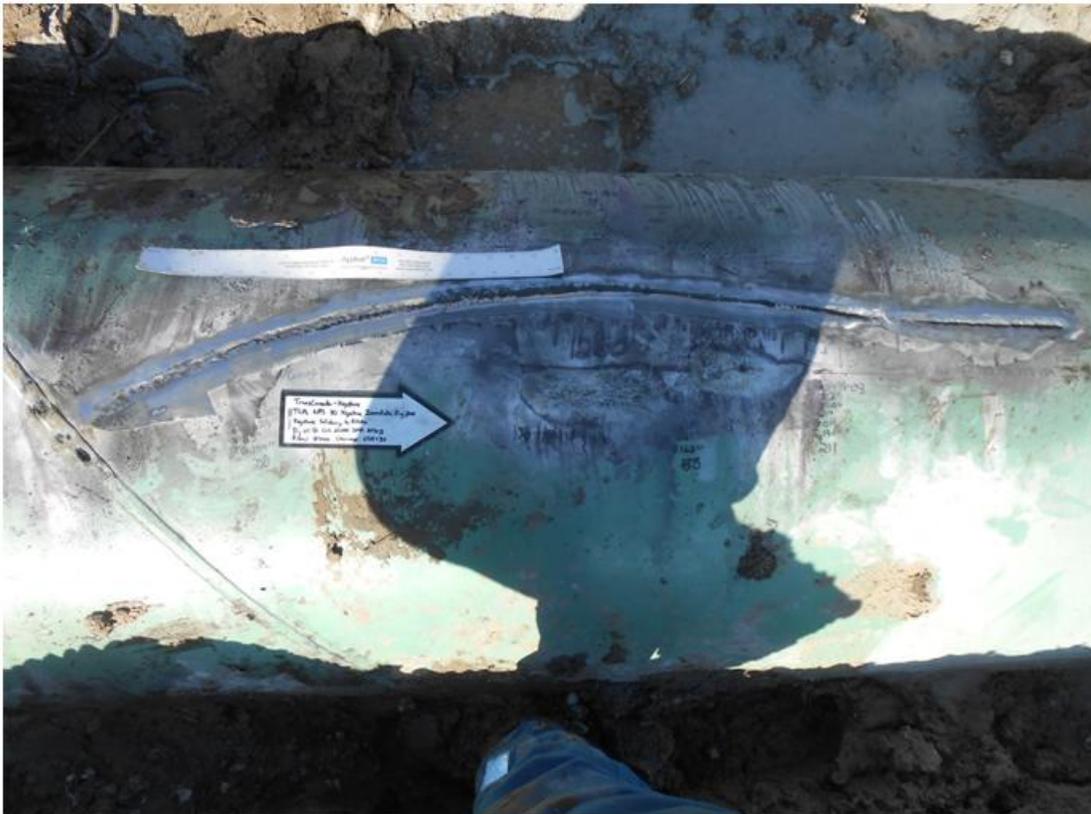
Figure 18. MP 997.67 – Axially Oriented External Corrosion at Areas of Coating Damage

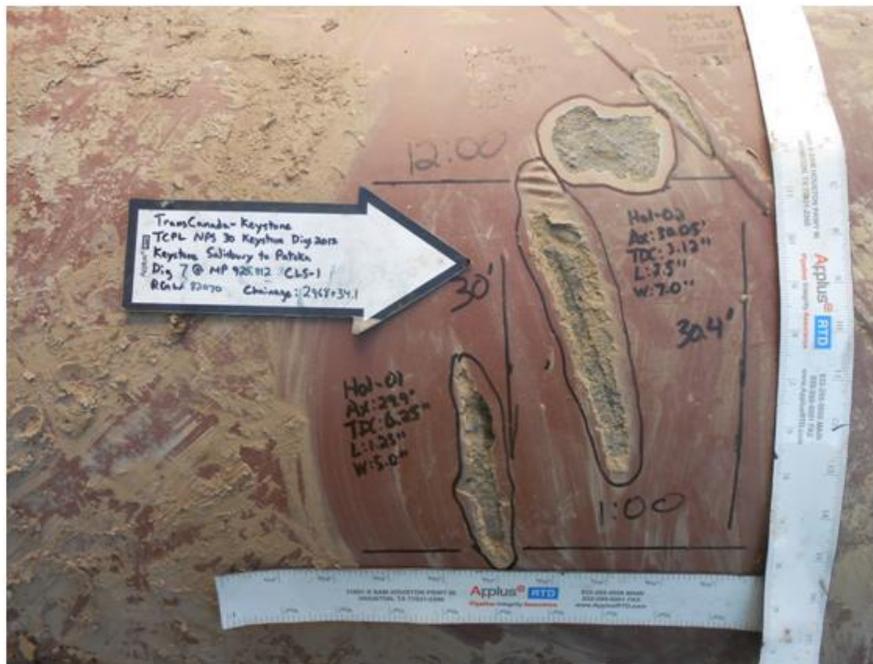
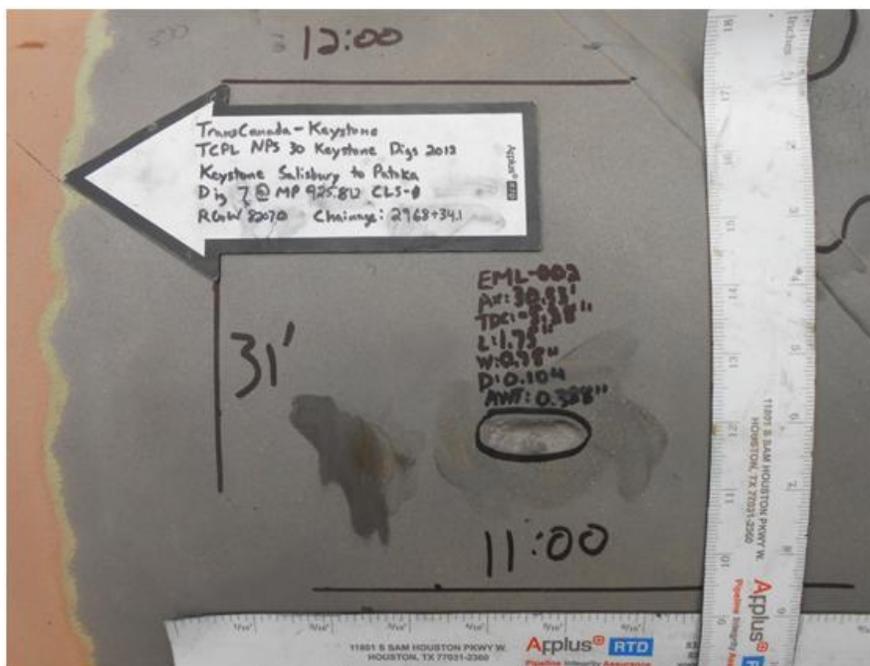
This anomaly was classified as a 180 day indication and was found to have two (2) anomalies caused by external corrosion with a peak depth of corrosion reported to be 30.05%. Approximately 5.0 feet of pipe was exposed from Station 1153+13.4 to 1153.18.3. The corrosion anomalies are dish shaped. The reported CP potentials documented in the RTD Dig report ranged from -0.600 v to -0.666 v (CSE). Soil pH was reported to be ranging from 4.5 to 5.5. The corrosion anomalies can be seen in Figures 19 and 20.

Figure 19. MP 921.81 – External Corrosion

Figure 20. MP 921.81 – External Corrosion

The observed corrosion is consistent with an accelerated rate of corrosion and may be associated with D-C Stray Current Corrosion.

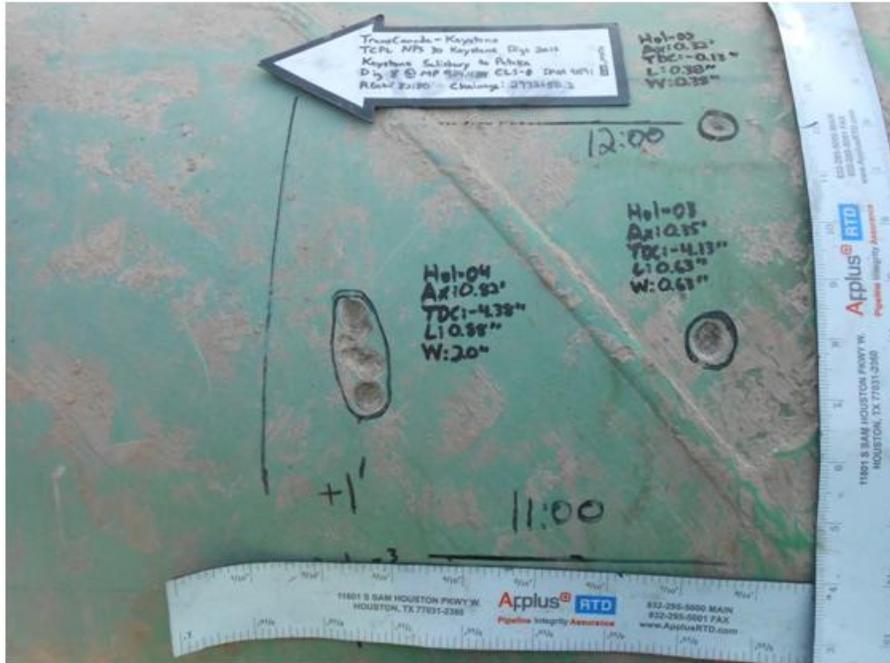
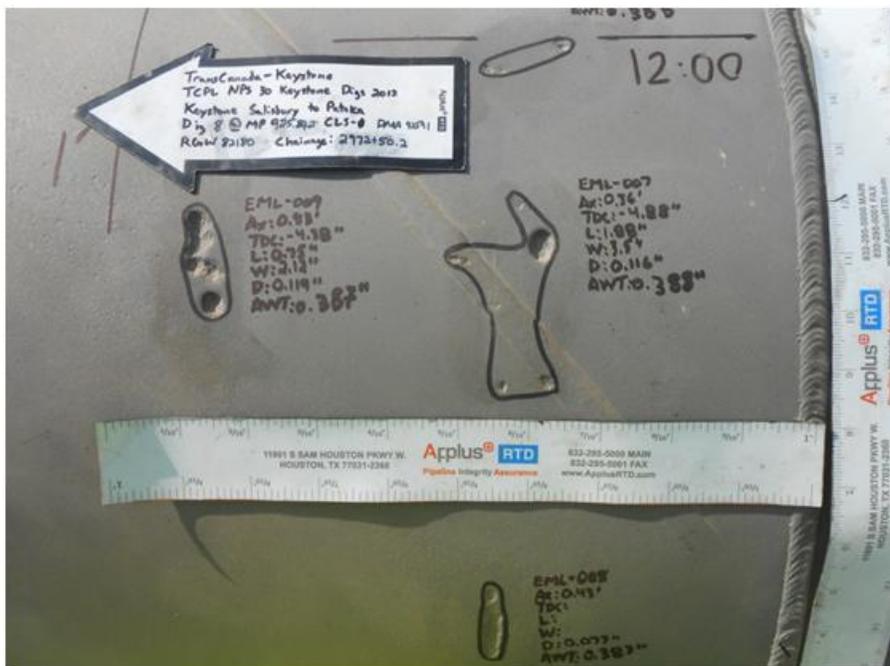
This anomaly was classified as a 180 day indication and was found to have five (5) anomalies caused by external corrosion with a peak depth of corrosion reported to be 30.75%. Approximately 6.0 feet of pipe was exposed from Station 1156+98.8 to 1157+04.8. The corrosion anomalies are dish shaped. The reported CP potentials documented in the RTD Dig report ranged from -0.735 v to -0.745 v (CSE). Soil pH was reported to be ranging from 5.0 to 5.5. The corrosion anomalies can be seen in Figures 21 and 22.

Figure 21. MP 925.89 – External Corrosion

Figure 22. MP 925.89 – External Corrosion

The accelerated rate of corrosion and the observed corrosion morphology along with an absence of tubercles is consistent with D-C Stray Current Corrosion.

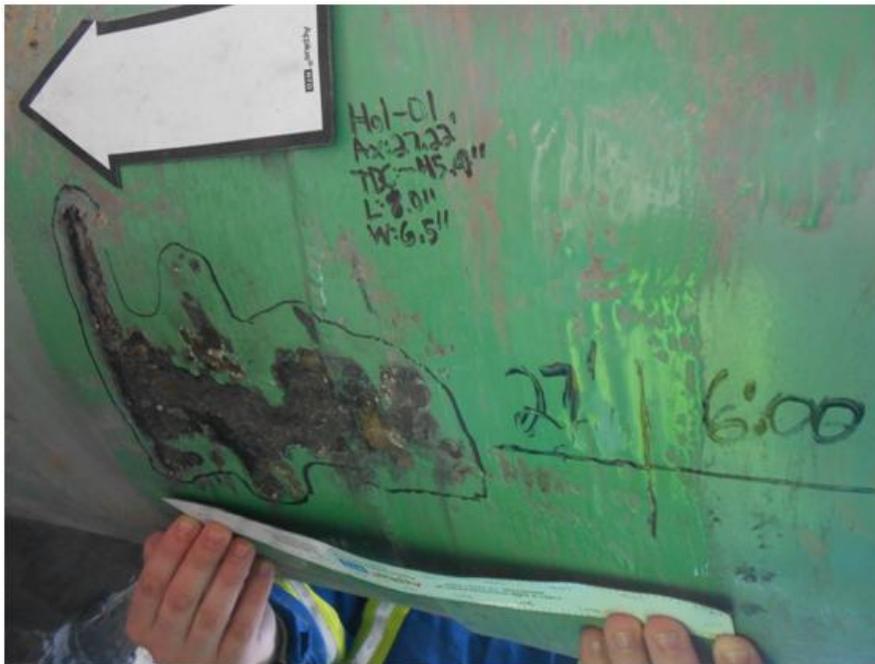
This anomaly was classified as a 180 day indication and was found to have one (1) anomaly caused by external corrosion with a peak depth of corrosion reported to be 46.45%. Approximately 5.0 feet of pipe was exposed from Station 809+97.1 to 810+02.1. The corrosion anomalies (one large commingled area and some discrete areas of metal loss) are dish shaped and occurred in a girth weld coating area. The reported CP potentials documented in the RTD Dig report ranged from -1.489 v to -1.523 v (CSE). Soil pH was reported to be ranging from 5.0 to 6.5. The corrosion anomalies can be seen in Figures 23 and 24.

Figure 23. MP 999.97 – Coating Damage

The corrosion damage at this location occurred at an accelerated rate and the morphology is consistent with stray current corrosion due to the absence of tubercles in the corroded area. MIC may also have contributed to the observed corrosion damage.

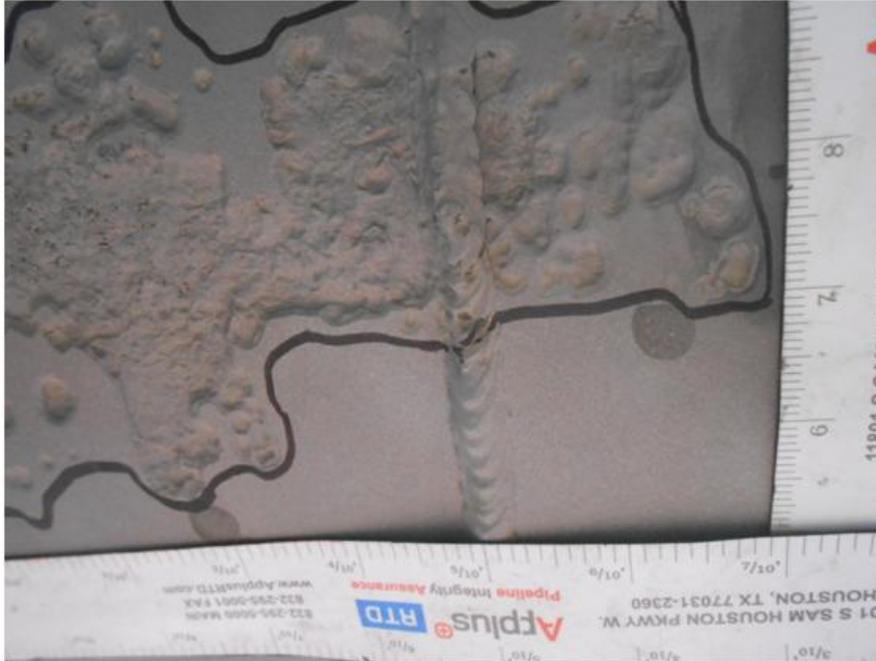
Figure 24. MP 999.97 – External Corrosion

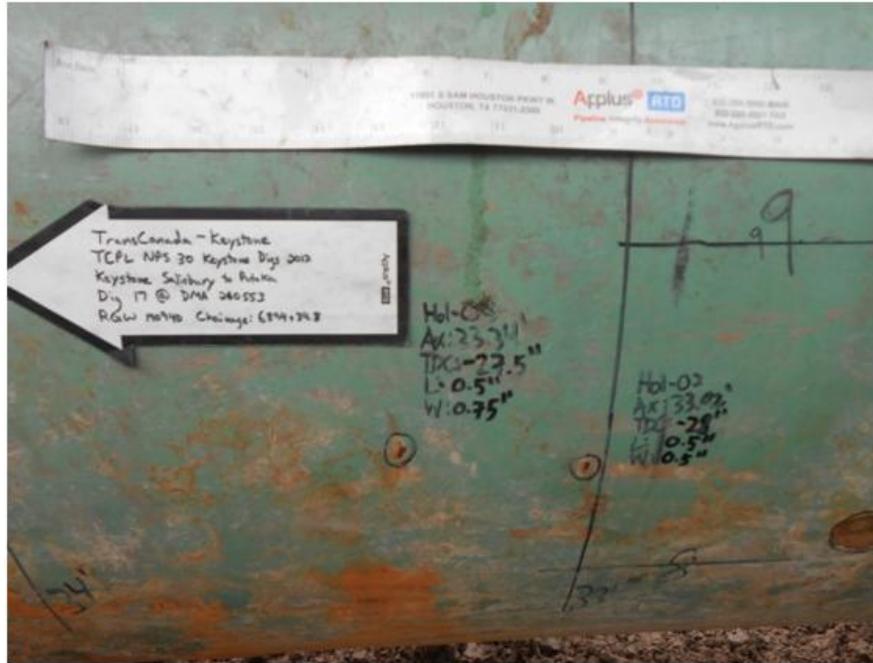
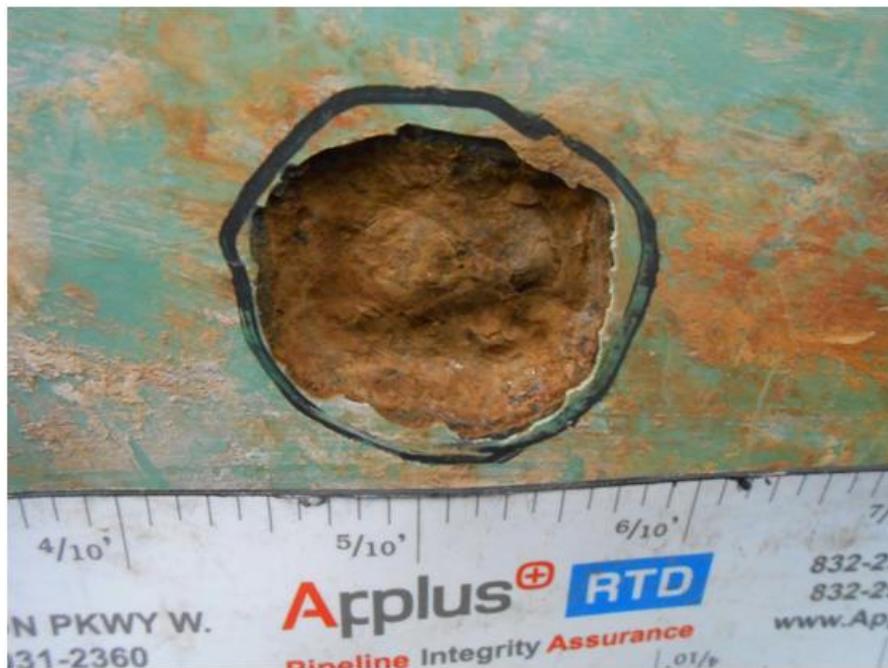
This anomaly was a Site #4 proximity examination and was found to have three (3) anomalies caused by external corrosion with a peak depth of corrosion reported to be 41.81%. Approximately 12.0 feet of pipe was exposed from Station 828+25.3 to 828+37.3. The corrosion anomalies (one large commingled area and some discrete areas of metal loss) are dish shaped. The reported CP potentials documented in the RTD Dig report ranged from -0.830 v to -0.840 v (CSE). Soil pH was reported to be ranging from 4.5 to 5.5. The corrosion anomalies can be seen in Figures 25 and 26.

Figure 25. MP1000.32 – External Corrosion Pitting

Figure 26. MP1000.32 – External Corrosion Pitting

The corrosion damage at this location occurred at an accelerated rate and the morphology is consistent with stray current corrosion.

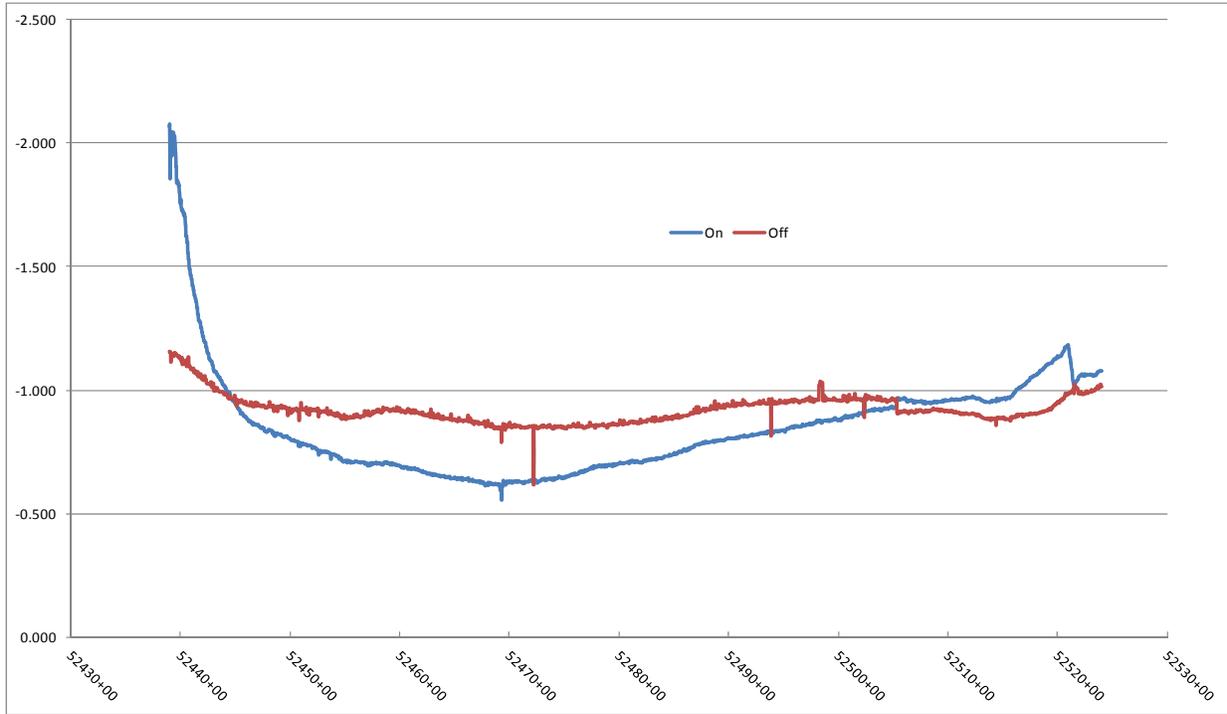
A CIS profile is shown in Figure 28. where there is evidence of reversed potentials indicative of a possible interference condition. This graph shows about 5000 lineal feet of reversed potentials. TransCanada reported that they had implemented interference bonds with foreign operators that may be influencing the Keystone system, but those bonds may not have been properly sized to achieve optimum results.

Figure 28. CIS Profile in the Area of External Metal Loss Anomalies MP 992.03-995.46⁷

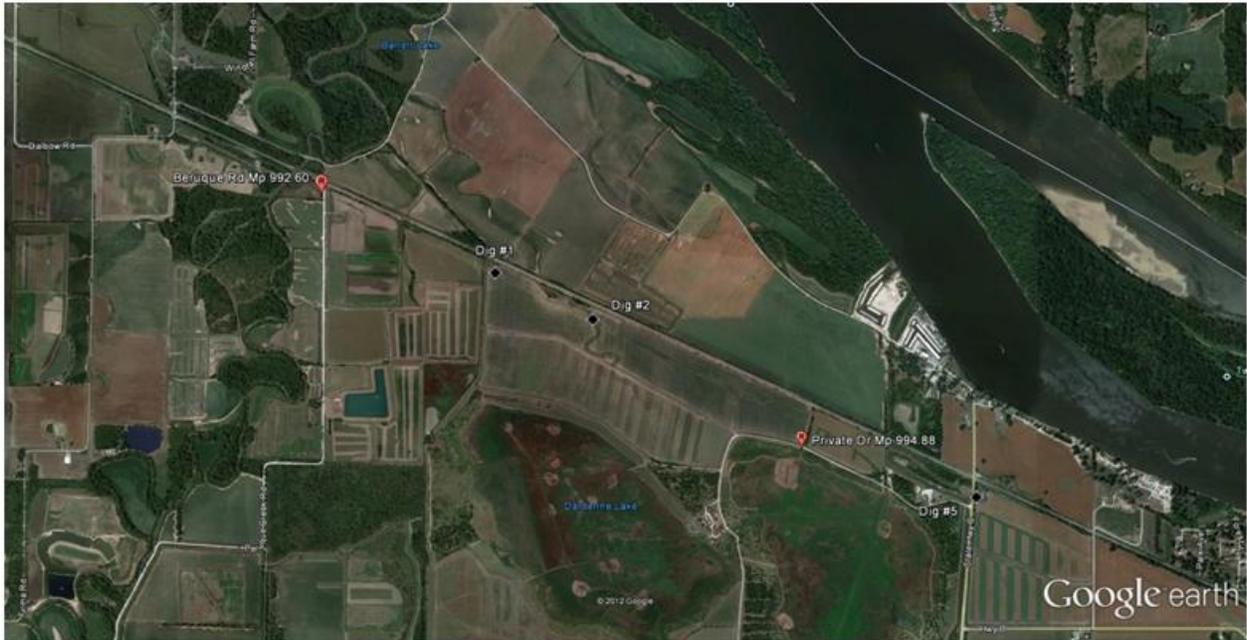
Figure 29. ILI Investigative Digs 1, 2 and 5.

The location of Foreign CP ground beds in relationship to the ILI anomaly digs is shown in Figures 29-31. These figures demonstrate the close proximity of possible sources of Interference.
