**Study of Root Cause and Contributing Factors  
Keystone Pipeline  
Corrosion Anomaly Investigation**

**Final Report**

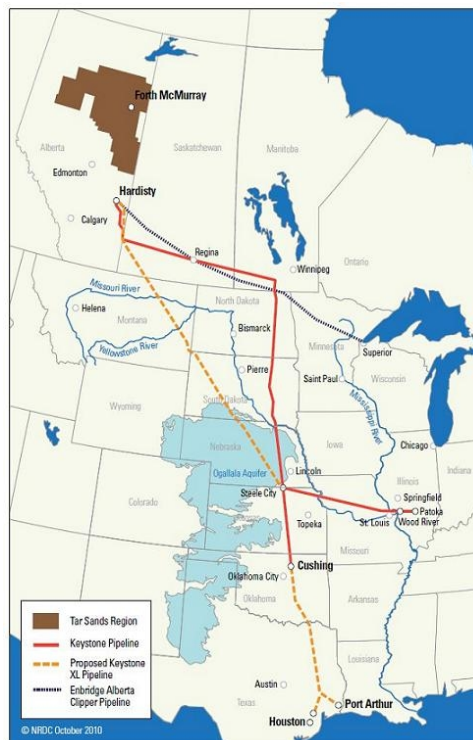
Figure 1. Keystone Pipeline System

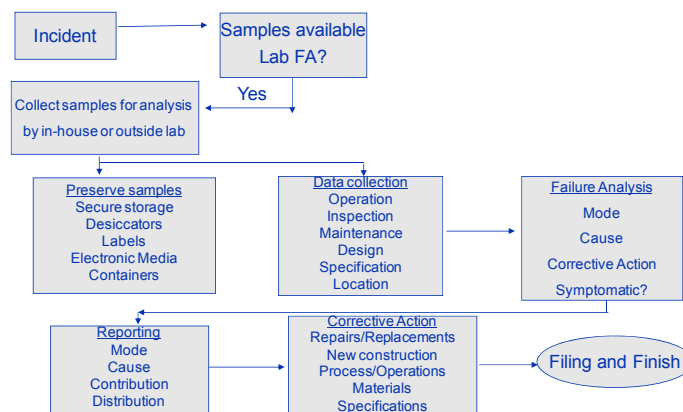
Adapted From MTI – David Hendrix

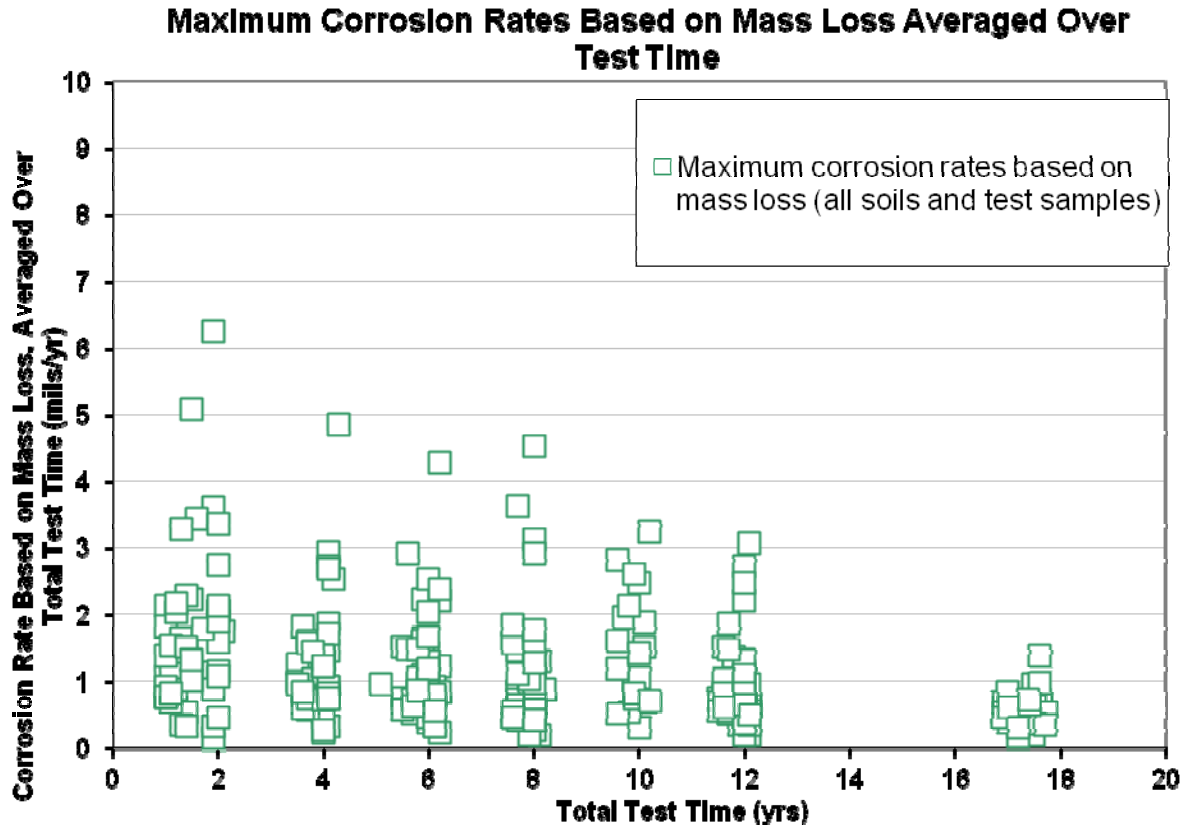
Establishing a reasonably conservative estimate of corrosion rates requires consideration for unique circumstances where corrosion of underground and submerged structures may be greatly accelerated. Mechanisms that can produce highly accelerated rates of corrosion on buried pipelines include:

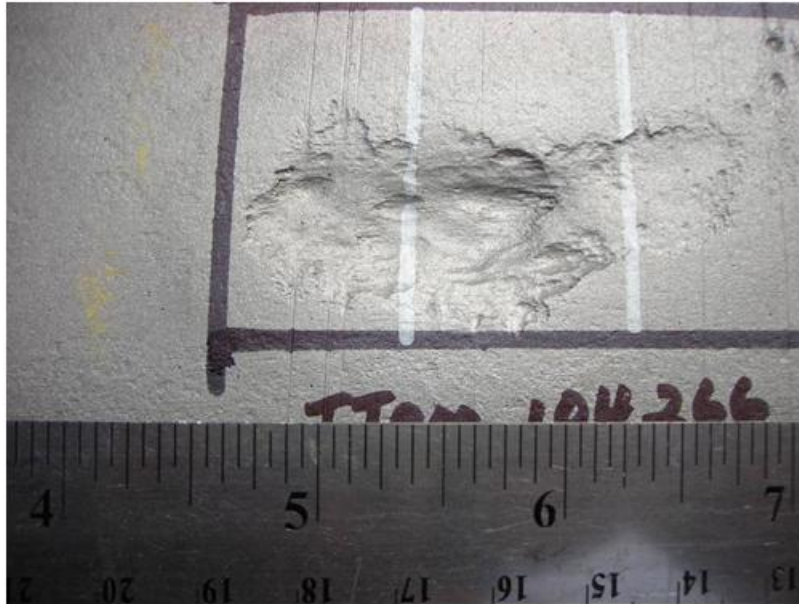
Figure 4. Typical MIC Morphology

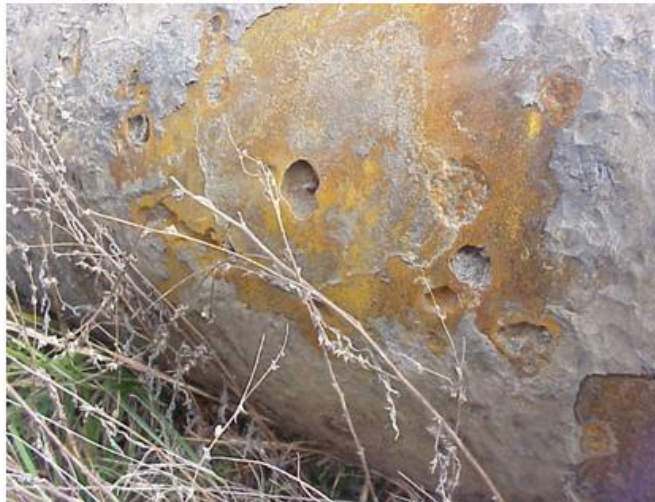
Figure 5. Typical D-C Stray Current Corrosion Morphology

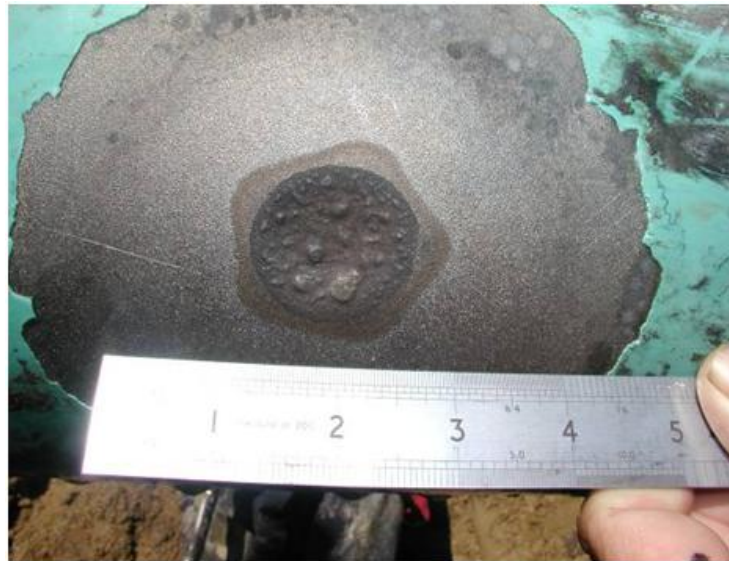
Figure 6. Typical A-C Corrosion Morphology

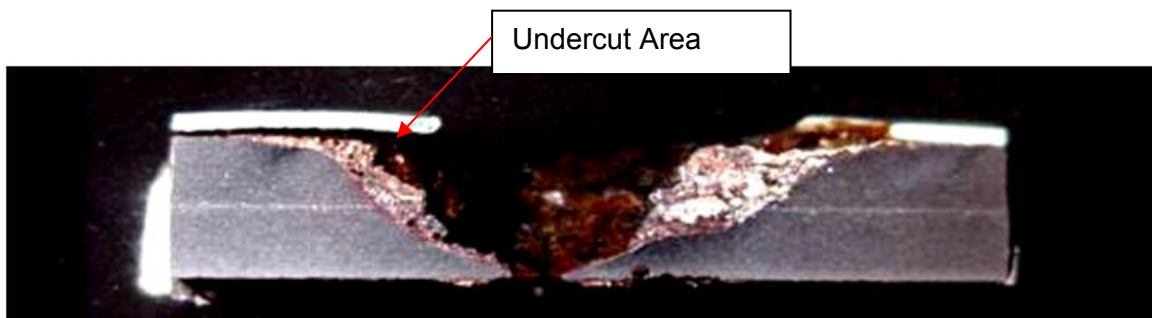
Figure 7. Metallographic Cross Section – Stray D-C Interference Corrosion (4-inch FBE Coated CS Pipeline)

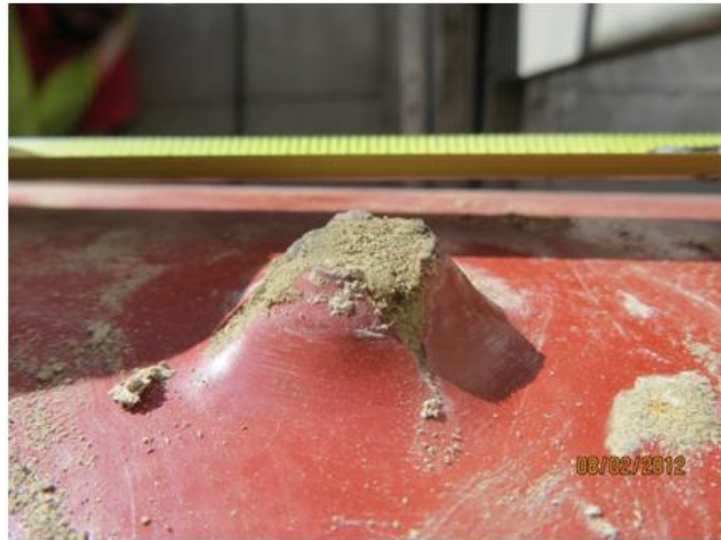
Figure 8. A-C Corrosion – FBE Coating “lift-off” and Cracking

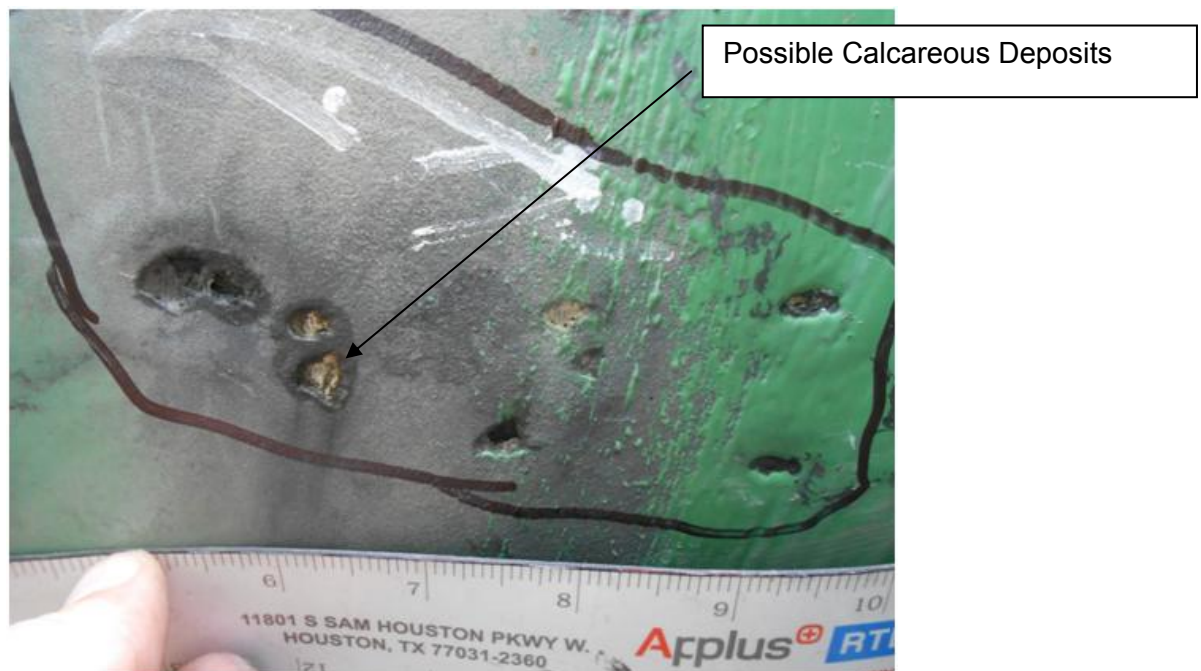
Figure 9. MP 995.95 External Corrosion Pitting

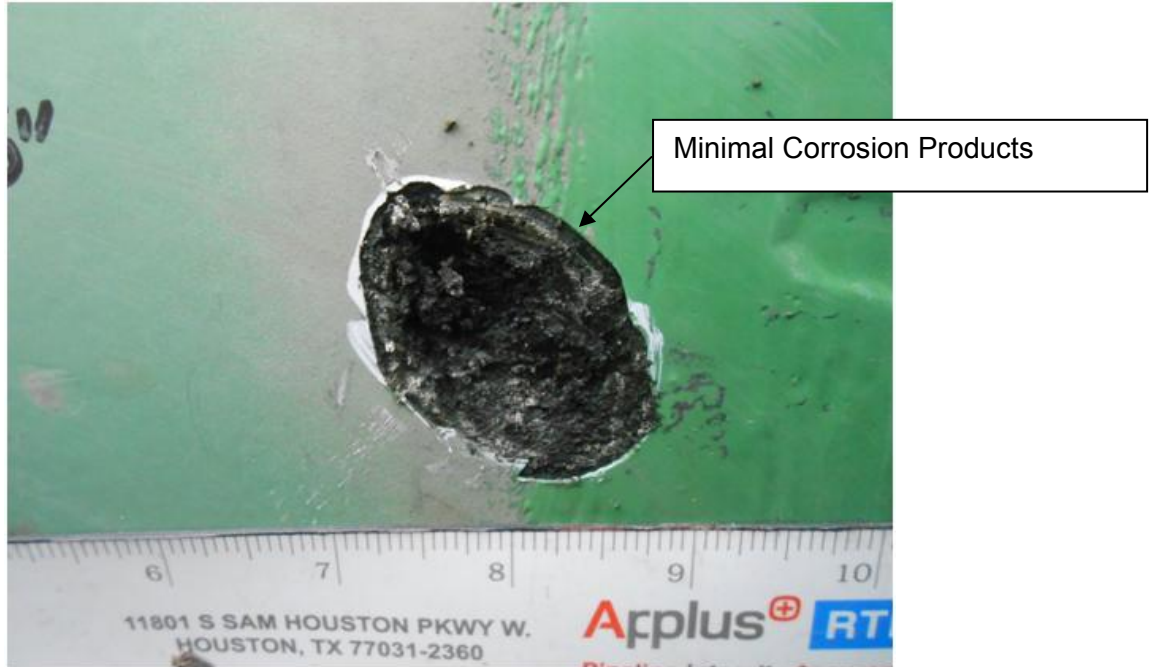
Figure 10. MP 995.95 –External Corrosion Pitting

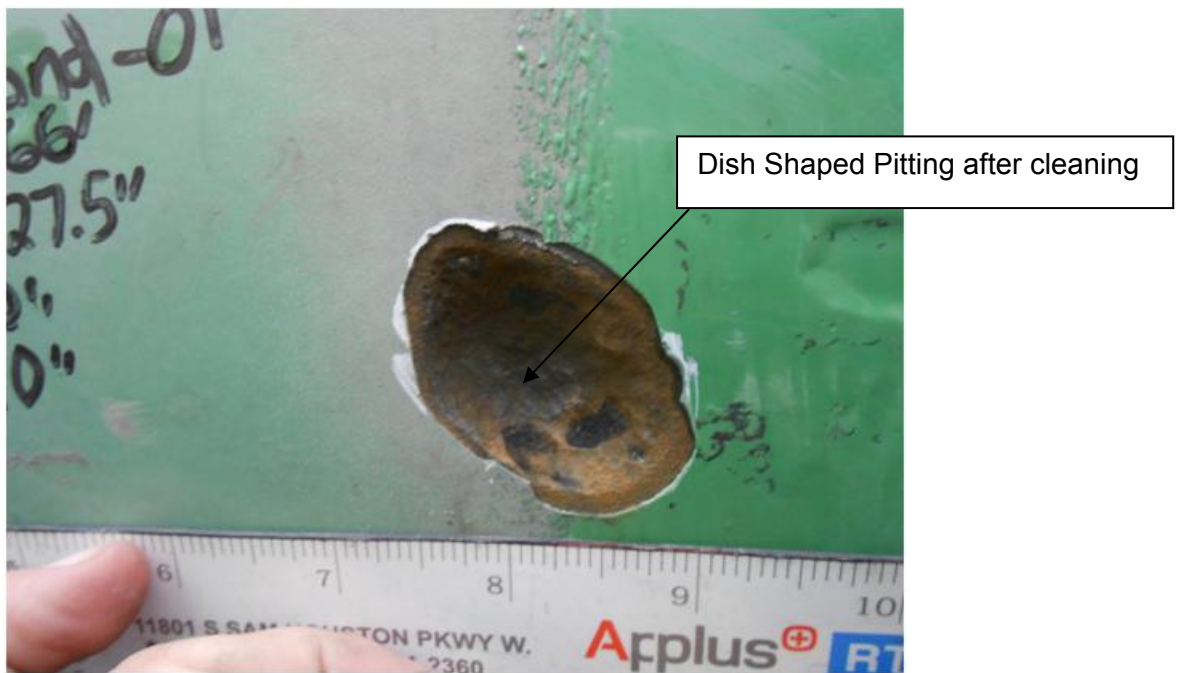
Figure 11. MP 995.95 –External Corrosion Pitting

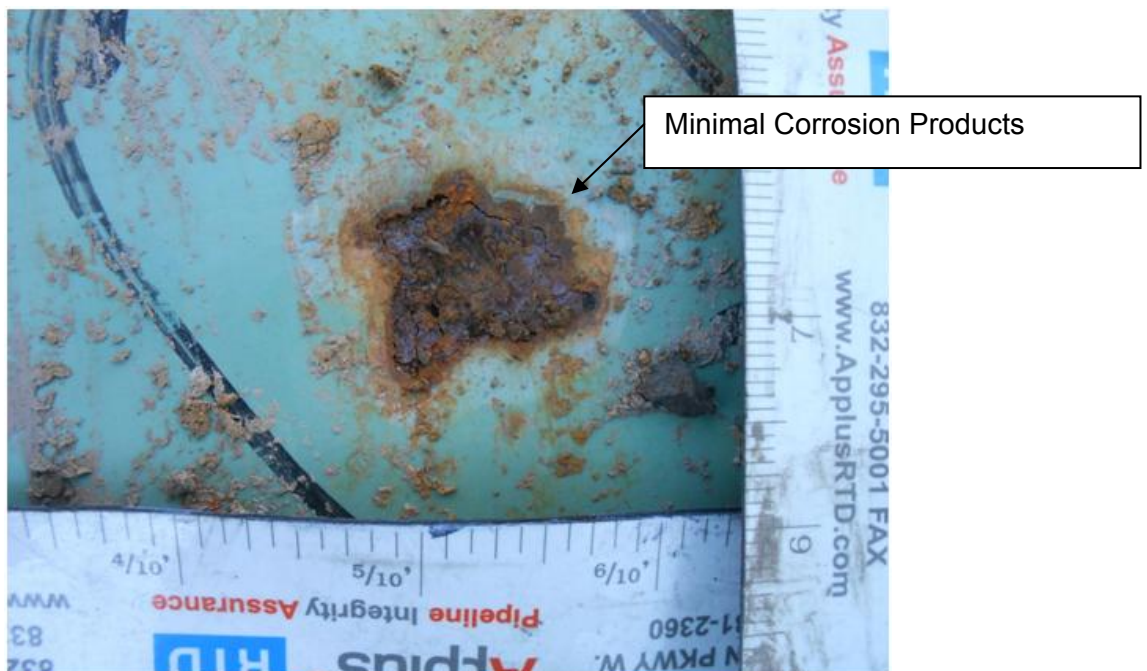
Figure 12. MP 996.33 –External Corrosion Pitting

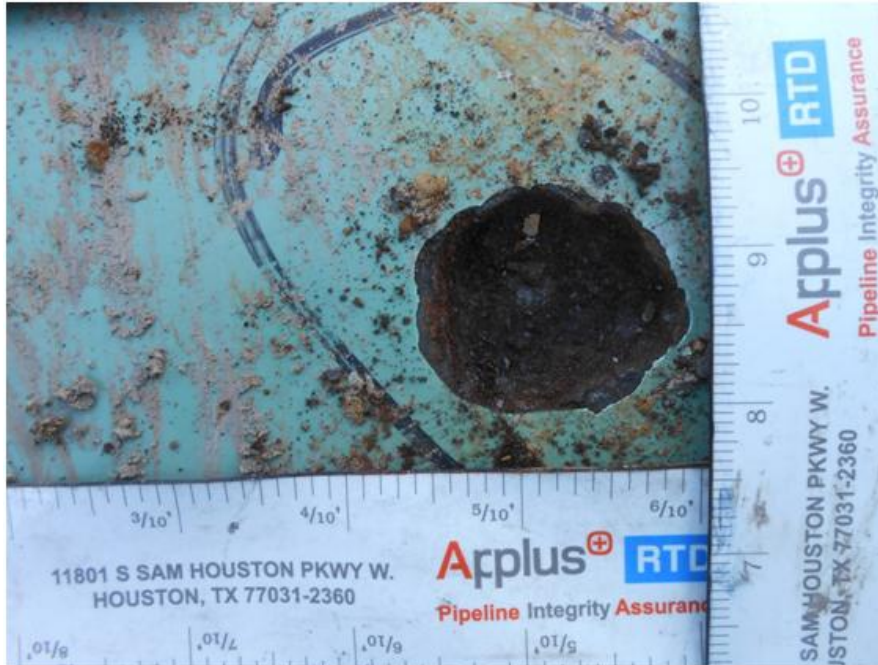
Figure 13. MP 996.33 –External Corrosion Pitting

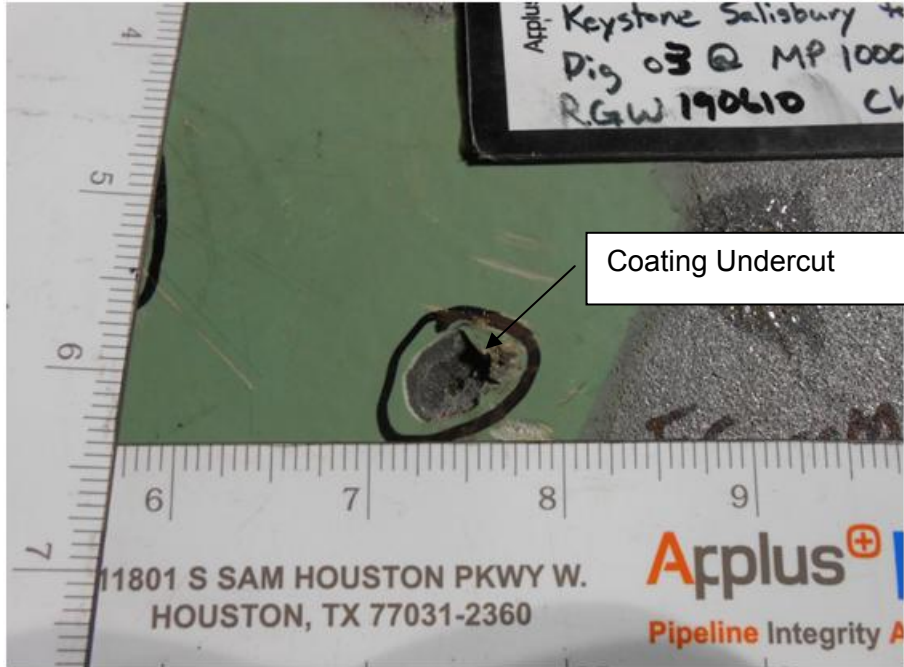
Figure 14. MP 1000.08 –External Corrosion Pitting

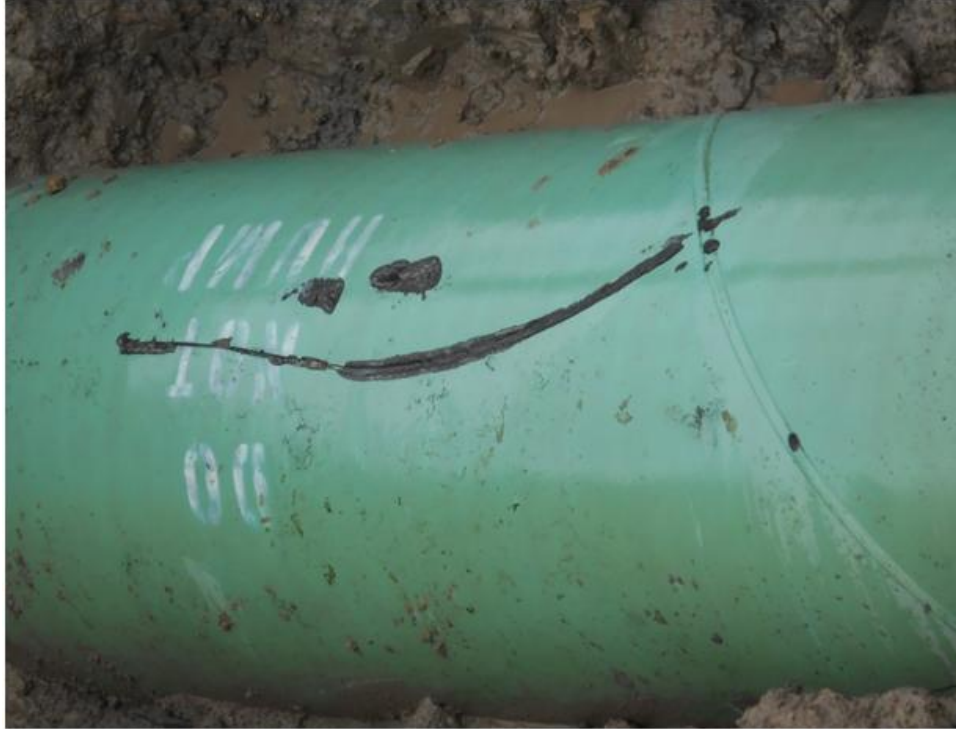
Figure 17. MP 997.67 –External Corrosion at Areas of Coating Damage

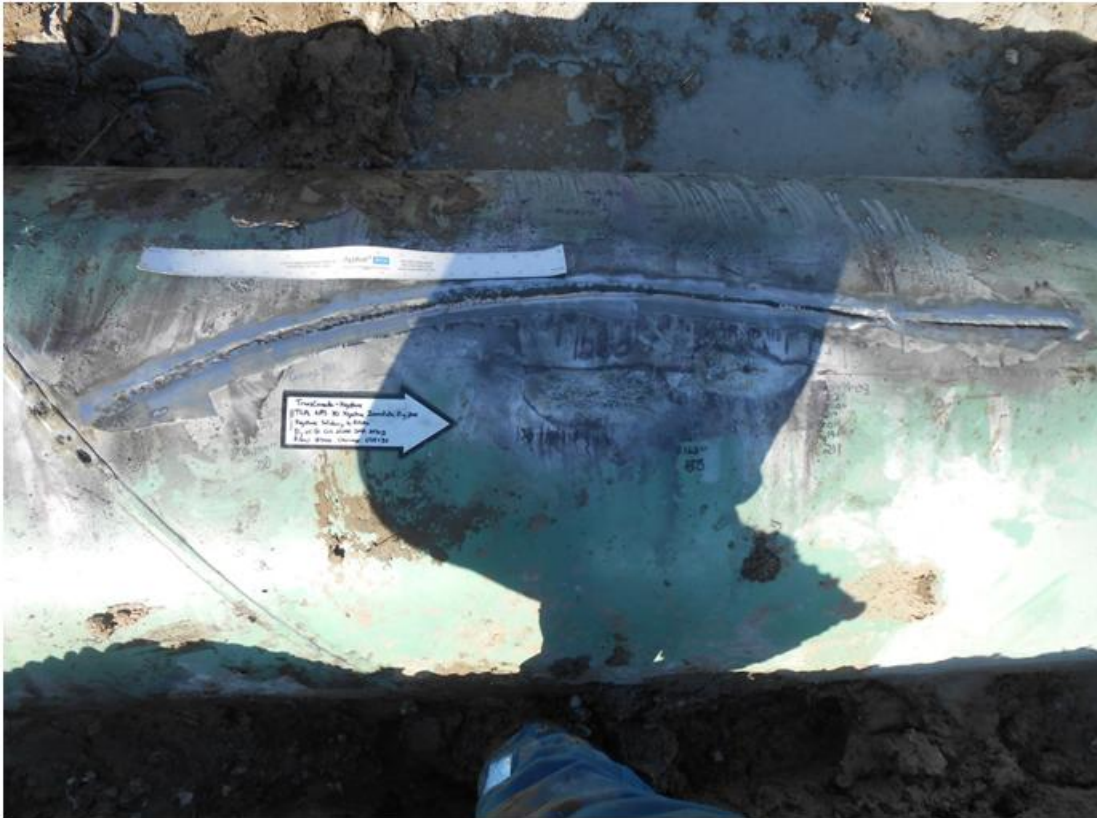
Figure 18. MP 997.67 – Axially Oriented External Corrosion at Areas of Coating Damage

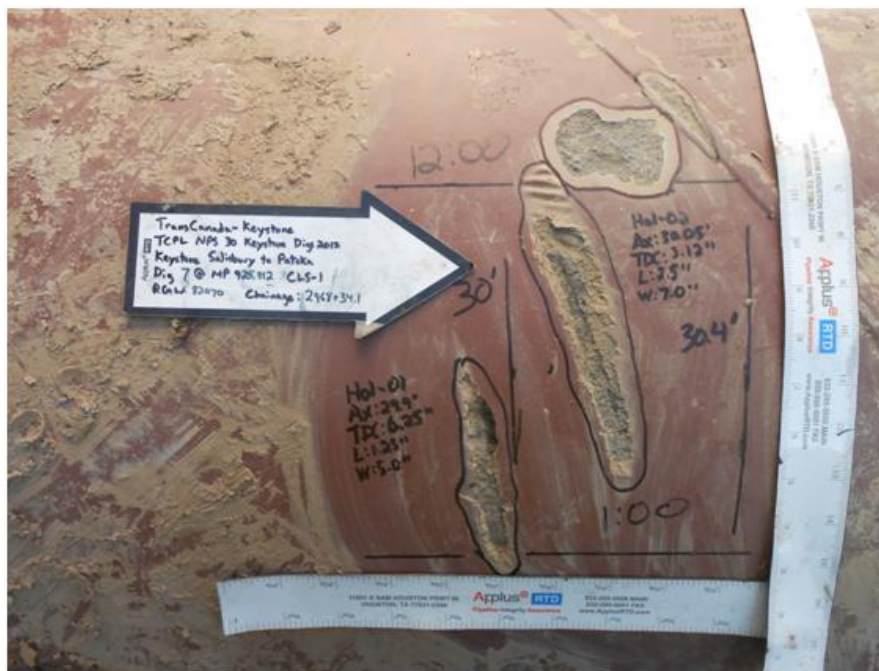
Figure 19. MP 921.81 – External Corrosion

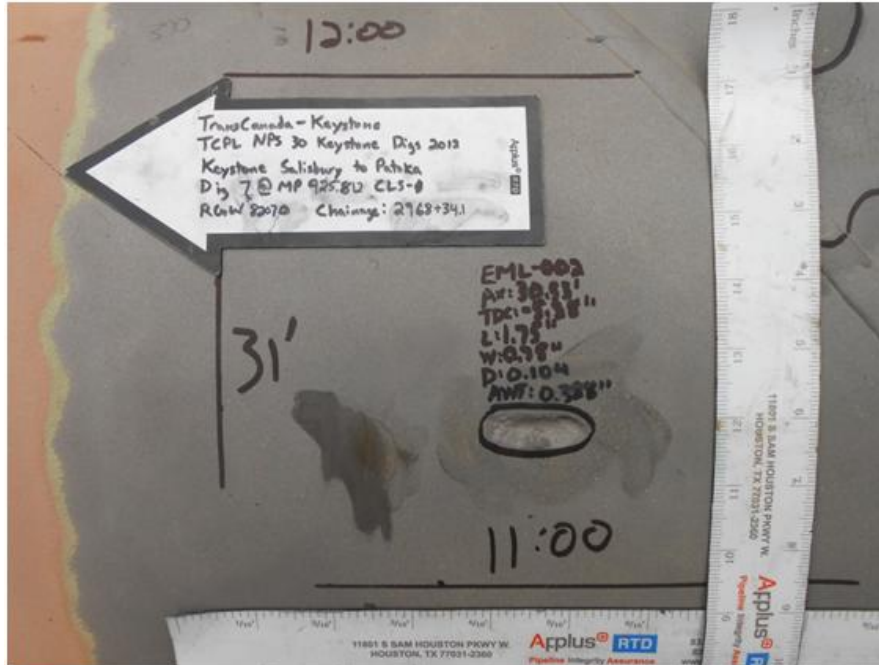
Figure 20. MP 921.81 – External Corrosion

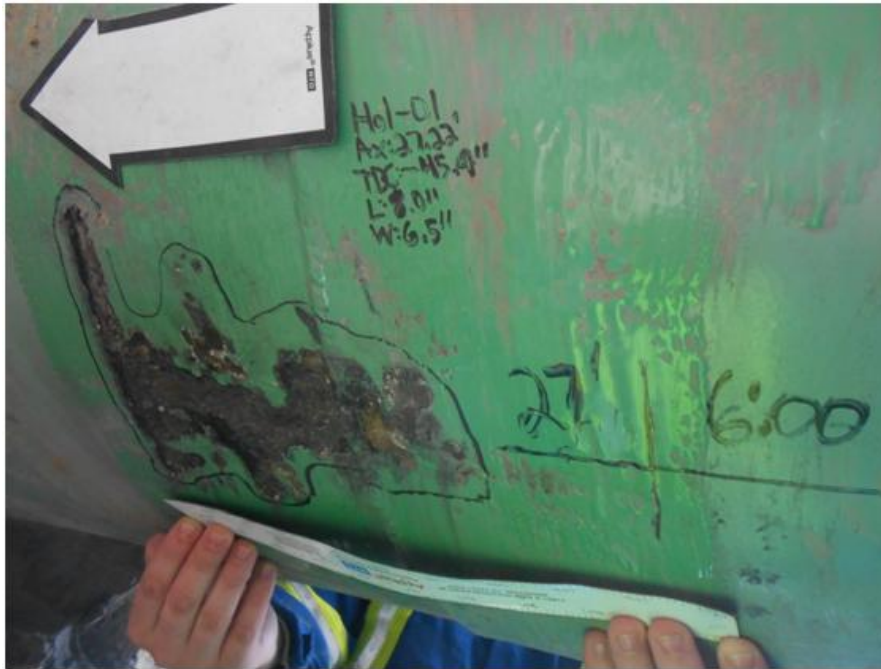
Figure 23. MP 999.97 – Coating Damage

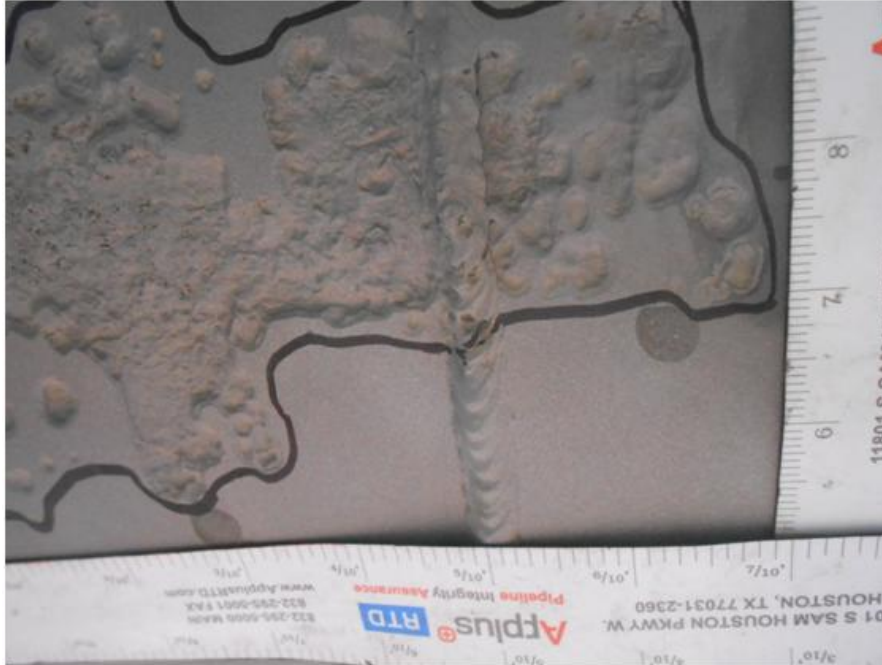
Figure 24. MP 999.97 – External Corrosion

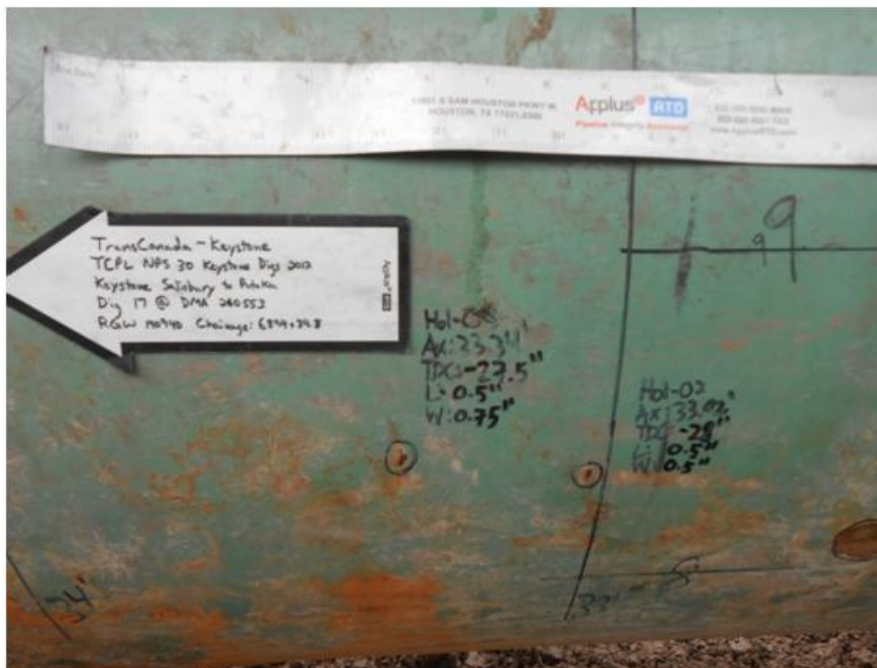
Figure 25. MP1000.32 – External Corrosion Pitting

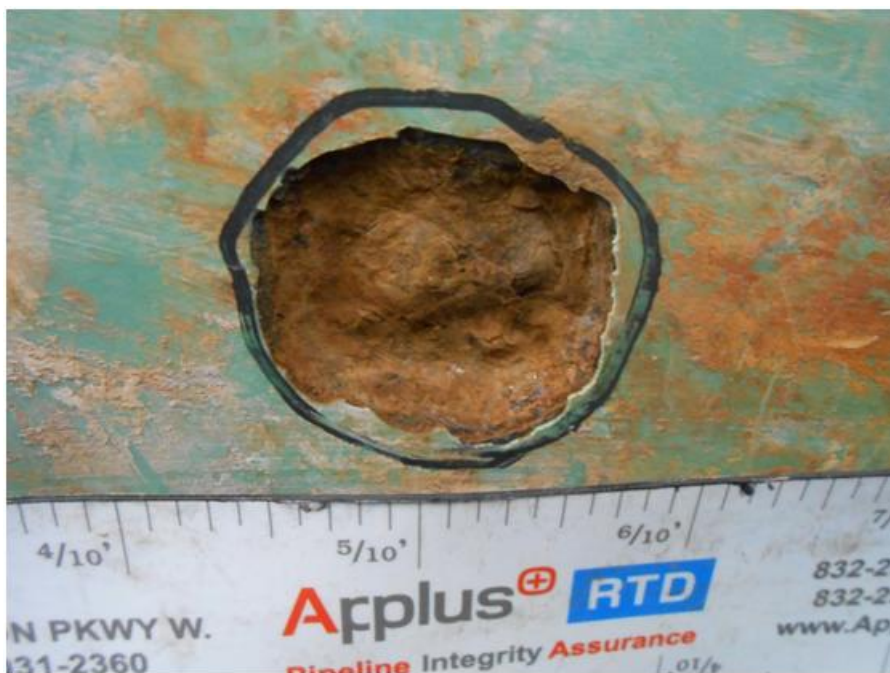
Figure 26. MP1000.32 – External Corrosion Pitting

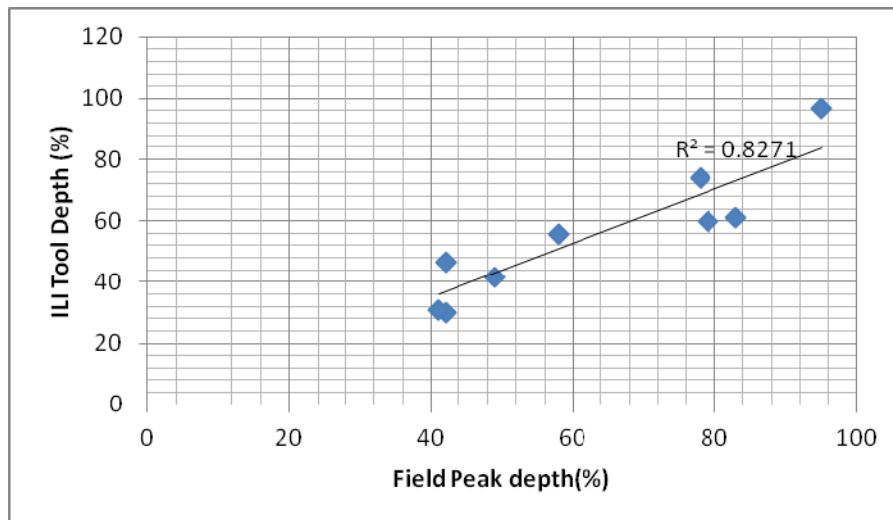
Figure 32. Unity Plot
