EVALUATION REPORT OF LIQUID PIPELINE CONSTRUCTION

Inspection Report		Post Inspection Memorandum	
Inspector/Submit Date: Southwest Region		Inspector/Submit Date:	
		Peer Review/Date:	
		Director Approval/Date:	
POST INSPECTION MEMORANDUM (PIM)			
Name of Operator:	TransCanada Oil Pipeline Operations Inc.		OPID #: 32334
Name of Unit(s):	Keystone Gulf Coast Pipeline North / Keystone Gulf Coast Pipeline South		Unit #(s): 74979,83245
Records Location:	Transcanada Sharepoint site, Contractor offices, Transcanada Office		Activity # 135840 & 140666
Unit Type & Commodity:	Interstate Liquids (Crude)		
Inspection Type:	Construction		Inspection Date(s): 2011-2014
PHMSA Representative(s):	Clint Stephens /Jon Manning /James Arnold / Noah Matthews/Barry Small/ Bill Lowry/ Basim Bacenty/ Joseph Elmer/ David Eng/ John Pepper	AFO Days:	165.9

Transcanada Keystone Pipeline LP, notified PHMSA in a letter dated September 30, 2011 of the construction of the Keystone Gulf Coast Pipeline starting in Q1 of 2012. The construction of the Keystone began in 2011 and was commissioned in 2014. Since 2011 until the commissioning of the pipeline on January 22, 2014, PHMSA, Southwest Region conducted onsite inspec

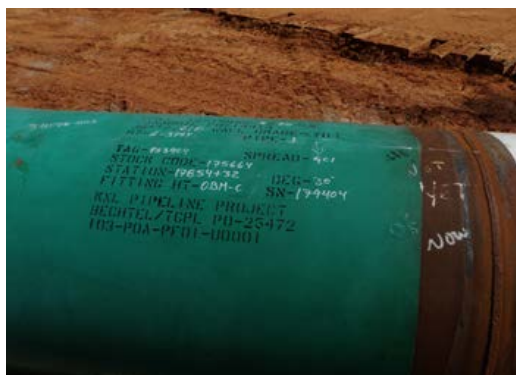
Figure 1: Pipe Specification Markings

During the field inspections, the pipeline was verified for design specifications by examining the pipe for manufacturer stamping and reviewing manufacturer test reports (MTRs). Each pipe joint was marked with length, grade, pipe size, and specification. See Figures 1 and 2 for examples.

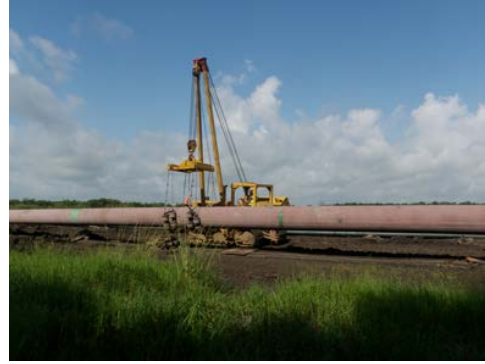
Figure 10: Boom holding Pipe

To avoid many road and railroad crossings, other pipeline, bodies of water and any other encroachments, TransCanada horizontally directional drilled (HDD) the pipeline at these locations. The depth of the HDDs well exceeded the depth of cover required by the regulations. PHMSA witnessed and inspected HDD construction activities for any issues and to assure specifications were followed. The Figures demonstrate the inspection of the HDDs. Figure 10 shows pipe is being supported by a boom as it is being pulled into the drill.

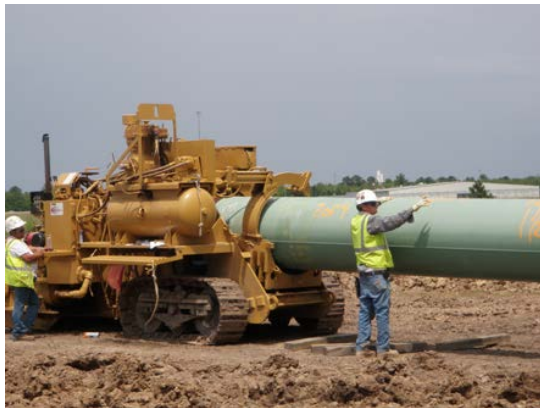
Figure 11: Bending Machine

Field pipe bends were observed by PHMSA during many field inspections. There were no wrinkle bends identified during these inspections. Pipe bends were performed by a bending machine which utilized an internal bending mandrel to achieve smooth and undistorted bends. PHMSA witnessed pipe bending activities which are shown in Figures 11 and 12. There was no mechanical damage identified during the pipe bending activities.

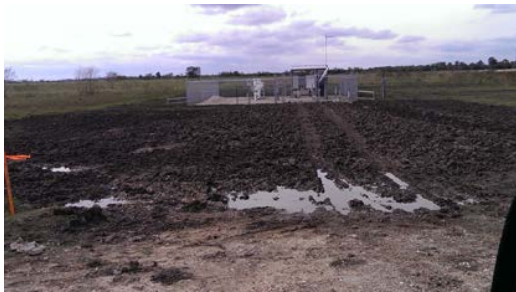
Figure 13: Typical Valve location

Valve locations and automation equipment were verified during the field inspections by PHMSA.

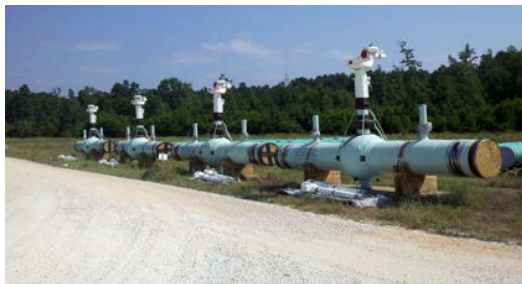
Figure 15: Valve Storage at Pipe Yard

Valves were inspected at the pipe yard on several occasions to verify the rating and condition of the valves. Figure 15 shows valves inspected at the pipe yard. Valves were stored away from the pipe to protect from any damage.

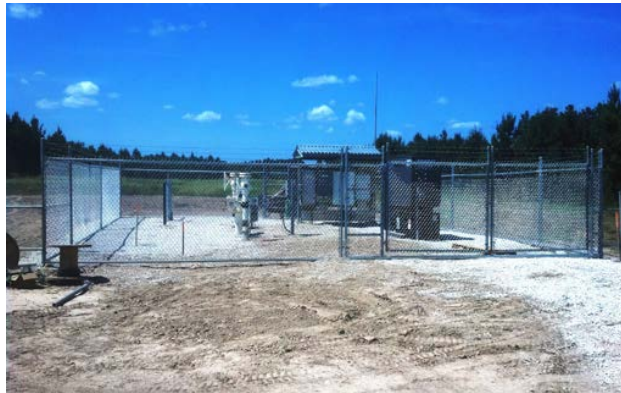
Figure 18: Typical Fencing around Valve site

All valves are motorized and remotely operational through SCADA. All valves had concrete foundation poured to handle any stresses the weight may put on the pipeline. Figure 17 is an example of concrete supports. Figure 18 demonstrates the protection from unauthorized personnel and vandalism. In addition, the photos show the satellite, electric power and generators for backup needed to operate the valves.

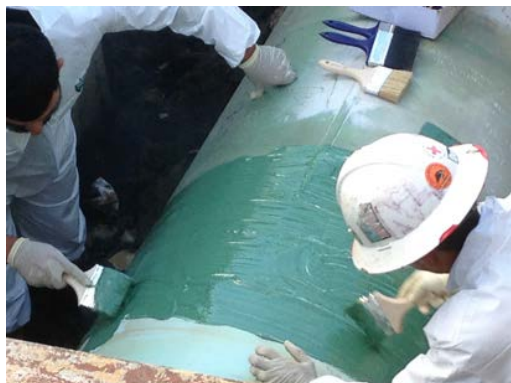
Figure 23: Coating of field joint

During the field inspections by PHMSA, the installation of corrosion control measures was verified. TransCanada provided corrosion control specifications which were reviewed by PHMSA. PHMSA witnessed the installation of many joints of pipe to assure that the coating was in good condition and was inspected (jeeped) for coating damage before burying the pipe. Any damage identified by this inspection technique was repaired. Each weld joint was coated and is seen in Figure 23. PHMSA also verified that there were a sufficient number of test leads installed throughout the pipeline.

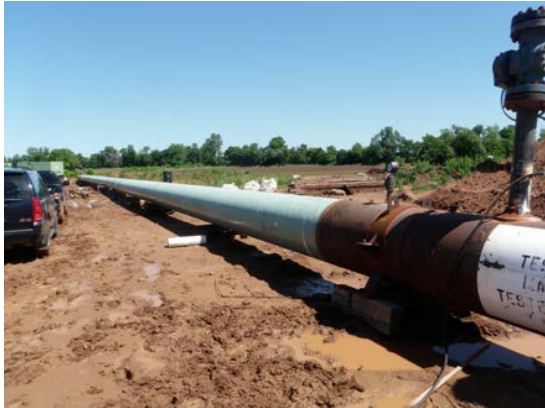
Figure 27: Hydrotest in Progress

Pressure testing of the TransCanada was performed in accordance with their Specification TES-PROJ-LPCS-US and with CFR 195. The specification and records of all hydrostatic pressure tests conducted by TransCanada were reviewed by PHMSA. In addition, PHMSA conducted field inspections of the hydrostatic testing on various locations of the pipeline.

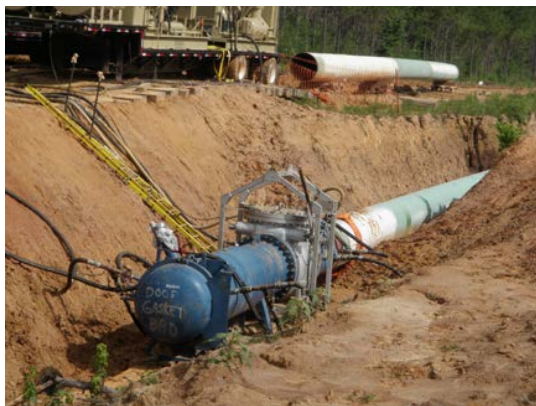
Figure 29: Drying process after hydrotest

The entire pipeline was hydrotested to at least 8 hours for all buried pipelines. In addition, TransCanada conducted a one hour pressure test on all HDD piping before pulling the pipe section. The one hour test is part of TransCanada's procedures to verify the integrity of the HDD pipe before pulling it through the drilled hole. The test medium used for all testing was water. All records reviewed had documented the appropriate pressure of 125% or more of MOP, test medium, instrument calibration, pressure recording charts, temperature, date and time and description of the facility being tested. TransCanada also provided elevation profiles of all test sections with hydraulic pressure profiles. There were no leaks or failures detected in the records review and during the field inspections.

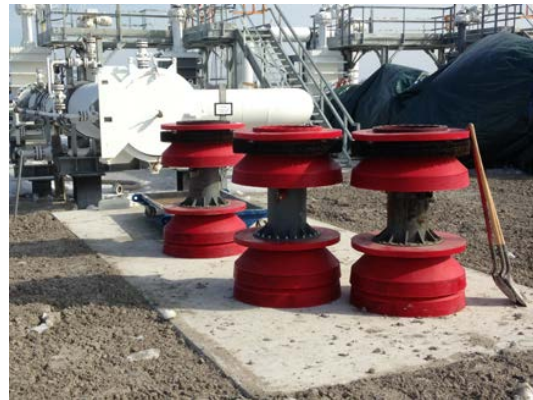
Figure 30: Pigs used during commissioning.

Product was tracked utilizing three batch pigs to assure the location of the product. Each pig was tracked by Corrpro personnel and predetermined above ground markers (AGM). During the commissioning phase, each mainline valve was operated to assure no leaks and satisfactory operation of the valve. In addition each pump station was started up in stages. Each stage consisted of testing each leak detection system and alarms per pump before
