EVALUATION REPORT OF LIQUID PIPELINE CONSTRUCTION

Transcanada Keystone Pipeline LP, notified PHMSA in a letter dated September 30, 2011 of the construction of the Keystone Gulf Coast Pipeline starting in Q1 of 2012. The construction of the Keystone began in 2011 and was commissioned in 2014. Since 2011 until the commissioning of the pipeline on January 22, 2014, PHMSA, Southwest Region conducted onsite inspections and reviewed documents which include construction specifications, construction inspection reports, welding qualifications, etc., submitted by Transcanada. A total of 165.9 AFO days and 53.35 non-AFO days were spent on the Transcanada construction project.

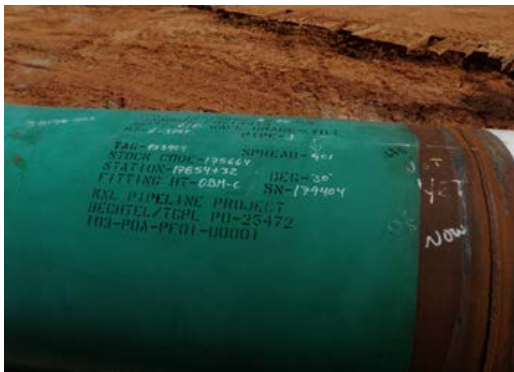
Figure 1: Pipe Specification Markings

During the field inspections, the pipeline was verified for design specifications by examining the pipe for manufacturer stamping and reviewing manufacturer test reports (MTRs). Each pipe joint was marked with length, grade, pipe size, and specification. See Figures 1 and 2 for examples.

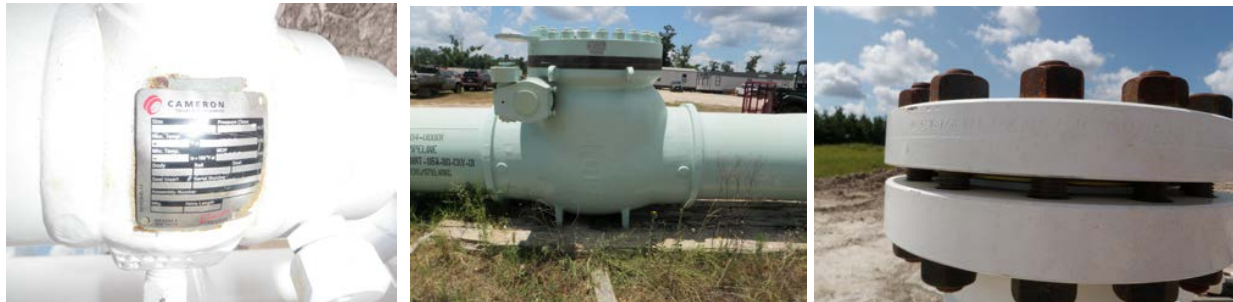
Figures 4, 5, 6: Manufacturer Stamp on Valve, and Flange

Valves and other pipeline components were also verified in the field. Valves were manufactured in accordance with API 6D and were stamped with manufacturer's name, maximum pressure rating, temperature rating, nominal size and body material. Fittings were

examined for damage such as buckles, dents, gouges, cracks or other defects that might reduce the strength. Pipe joints were tracked by a labeling system with a bar code. See Figures 4-6.

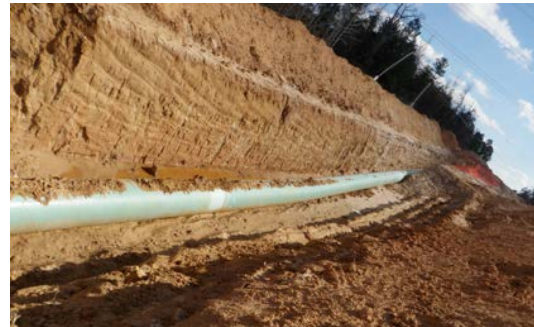
Figure 8: Typical Right of Way depicting Depth of Cover.

During the field inspections, PHMSA inspected the pipeline ROW for any private dwellings, industrial buildings, and places of assembly. The ROW of the pipeline avoided and was not in close proximity to any of these structures or locations. The inspection of soil cover and depth of pipe was in compliance with the regulations. The pipeline had a cover of at least the minimum cover required at all locations inspected during the field inspections. Figure 8 shows the depth of the pipe. The Figure demonstrates the cover and depth of the pipeline and the remoteness of the pipeline ROW. Figure 9 shows the depth of pipeline is verified with a GPS system.

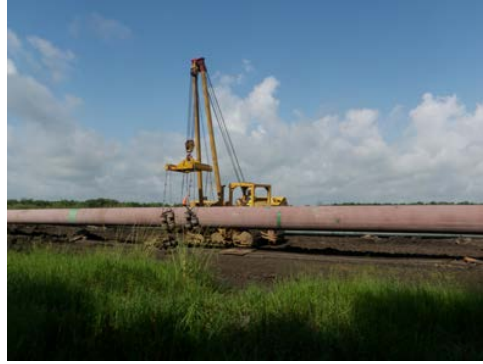
Figure 10: Boom holding Pipe

To avoid many road and railroad crossings, other pipeline, bodies of water and any other encroachments, TransCanada horizontally directional drilled (HDD) the pipeline at these locations. The depth of the HDDs well exceeded the depth of cover required by the regulations. PHMSA witnessed and inspected HDD construction activities for any issues and to assure specifications were followed. The Figures demonstrate the inspection of the HDDs. Figure 10 shows pipe is being supported by a boom as it is being pulled into the drill.

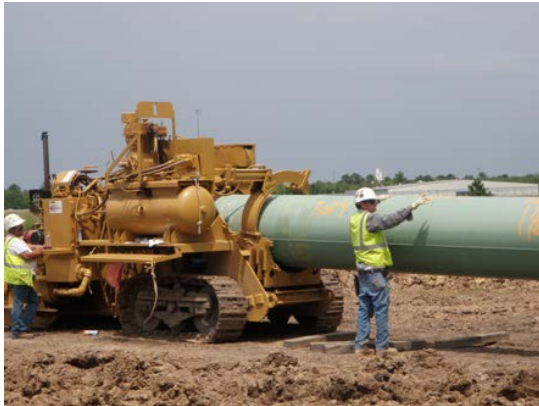
Figure 11: Bending Machine

Field pipe bends were observed by PHMSA during many field inspections. There were no wrinkle bends identified during these inspections. Pipe bends were performed by a bending machine which utilized an internal bending mandrel to achieve smooth and undistorted bends. PHMSA witnessed pipe bending activities which are shown in Figures 11 and 12. There was no mechanical damage identified during the pipe bending activities.

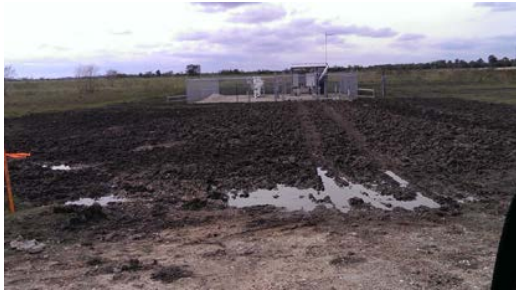
Figure 13: Typical Valve location

Valve locations and automation equipment were verified during the field inspections by PHMSA.

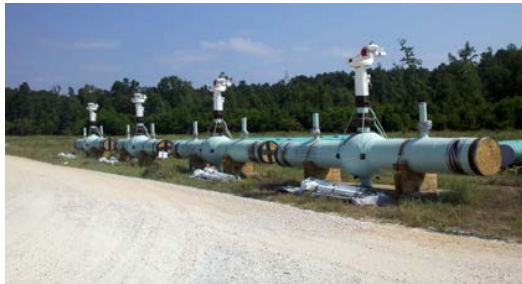
Figure 15: Valve Storage at Pipe Yard

Valves were inspected at the pipe yard on several occasions to verify the rating and condition of the valves. Figure 15 shows valves inspected at the pipe yard. Valves were stored away from the pipe to protect from any damage.

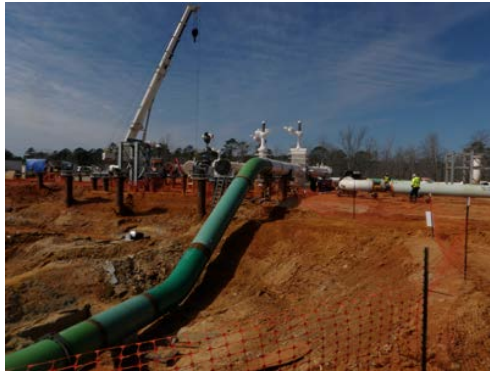
Figure 16: Valve at Pump Station

There were also valves located at each discharge and suction side of the pump stations. Figure 16 depicts an example of a pump station valve installation.

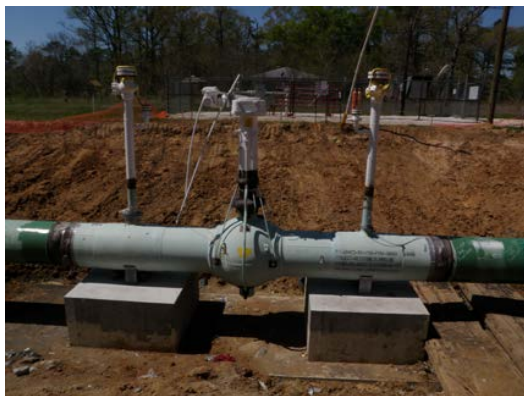
Figure 17: Concrete Pads for Valves.

All valves are motorized and remotely operational through SCADA. All valves had concrete foundation poured to handle any stresses the weight may put on the pipeline. Figure 17 is an example of concrete supports. Figure 18 demonstrates the protection from unauthorized personnel and vandalism. In addition, the photos show the satellite, electric power and generators for backup needed to operate the valves.

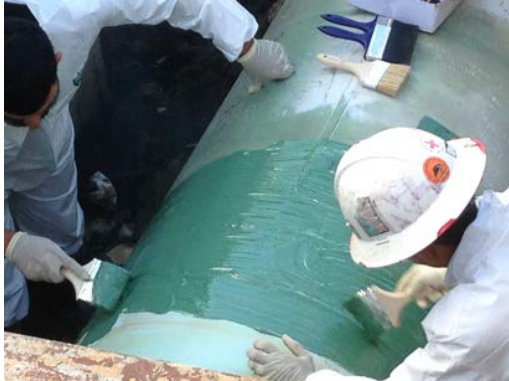
Figure 23: Coating of field joint

During the field inspections by PHMSA, the installation of corrosion control measures was verified. TransCanada provided corrosion control specifications which were reviewed by PHMSA. PHMSA witnessed the installation of many joints of pipe to assure that the coating was in good condition and was inspected (jeeped) for coating damage before burying the pipe. Any damage identified by this inspection technique was repaired. Each weld joint was coated and is seen in Figure 23. PHMSA also verified that there were a sufficient number of test leads installed throughout the pipeline.

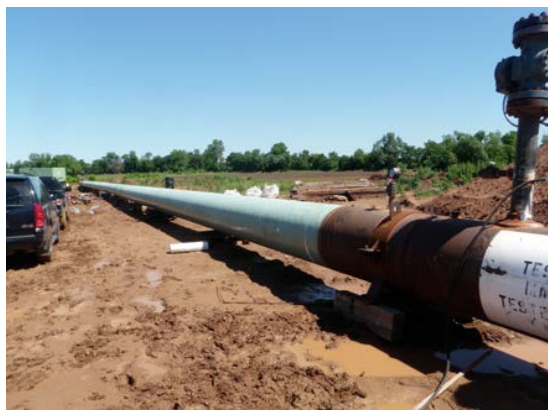
Figure 27: Hydrotest in Progress

Pressure testing of the TransCanada was performed in accordance with their Specification TES-PROJ-LPCS-US and with CFR 195. The specification and records of all hydrostatic pressure tests conducted by TransCanada were reviewed by PHMSA. In addition, PHMSA conducted field inspections of the hydrostatic testing on various locations of the pipeline.

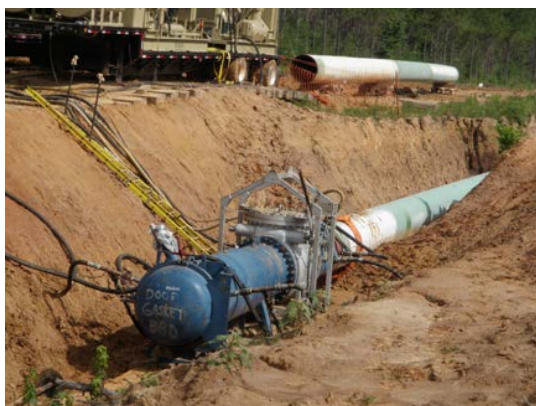
Figure 29: Drying process after hydrotest

The entire pipeline was hydrotested to at least 8 hours for all buried pipelines. In addition, TransCanada conducted a one hour pressure test on all HDD piping before pulling the pipe section. The one hour test is part of TransCanada's procedures to verify the integrity of the HDD pipe before pulling it through the drilled hole. The test medium used for all testing was water. All records reviewed had documented the appropriate pressure of 125% or more of MOP, test medium, instrument calibration, pressure recording charts, temperature, date and time and description of the facility being tested. TransCanada also provided elevation profiles of all test sections with hydraulic pressure profiles. There were no leaks or failures detected in the records review and during the field inspections.

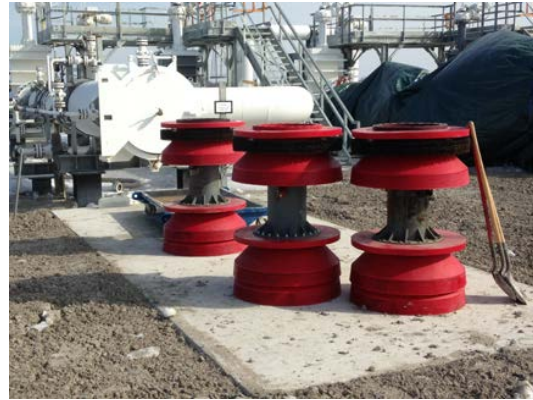
Figure 30: Pigs used during commissioning.

PHMSA received daily updates throughout the commissioning phase of all ongoing activities. In addition, PHMSA engineers/inspectors were onsite during the commissioning phase to witness and assure procedures were being followed by TransCanada personnel. PHMSA witnessed the line fill, testing of pump alarms and leak detection, valve testing and pig tracking operations. The Figures demonstrate the observations of the activities witnessed during the commissioning. The Figure 43 shows the pigs used to track the product while filling line. Figure 44 shows how the pigs were tracked from above ground.
