**Study of Root Cause and Contributing Factors
Keystone Pipeline
Corrosion Anomaly Investigation**

Final Report

2/13/2013

TransCanada

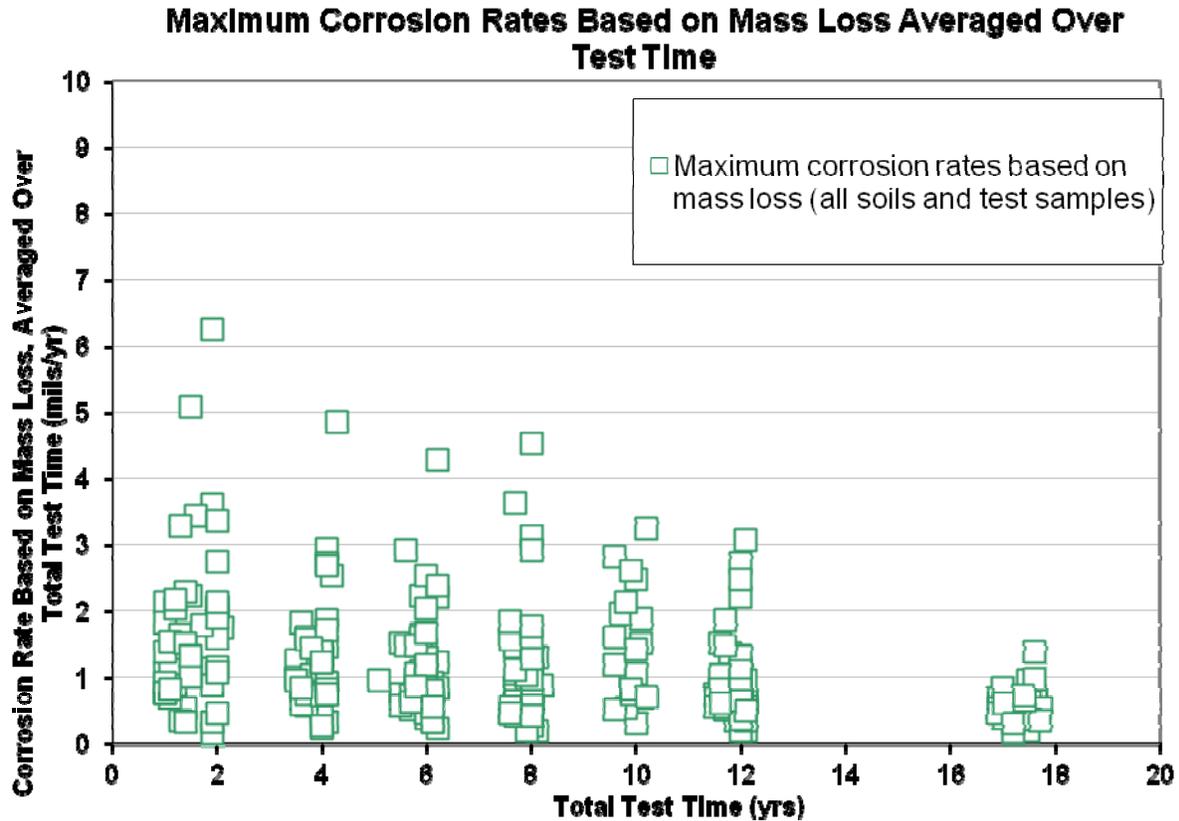
One of the most comprehensive sources of corrosion data is contained in the US National Bureau of Standards Circular's C401 (Stray Current Electrolysis), C450 (Underground Corrosion) and C579 (Underground Corrosion). A recent publication by NIST (the National Institute of Science and Technology), the successor to National Bureau of Standards, republished the compiled corrosion rate data in a statistical manner. For the purposes of this analysis the data have been reproduced in Figure 3. These data clearly show that corrosion rates for carbon steel buried in soils do not approach the rates experienced on the Keystone Pipeline. These rates are even more surprising since they occurred in the presence of cathodic protection which is intended to control corrosion.

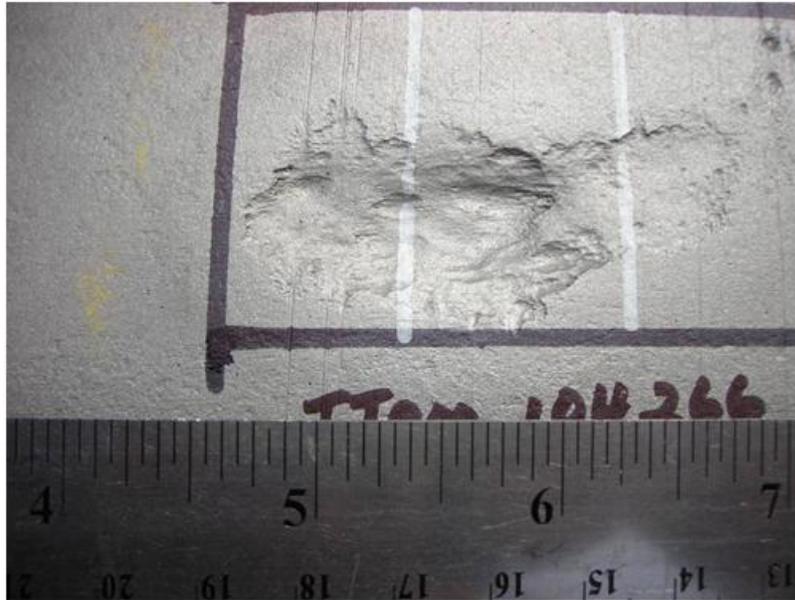
Figure 4. Typical MIC Morphology

MIC in soils has been documented to occur at rates approaching 4mm/yr (150mpy)). An example of the corrosion morphology associated with MIC is shown in Figure 4.

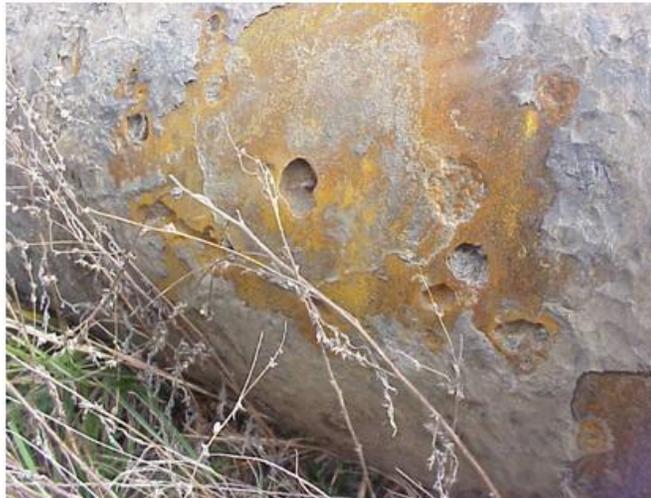
Figure 5. Typical D-C Stray Current Corrosion Morphology

The effects of stray direct current (D-C) on established corrosion rates cannot be readily quantified due to the significant metal removal power of D-C currents. Rates of 10mm/yr (250mpy) are expected. An example of the corrosion morphology associated with D-C interference current is shown in Figure 5.

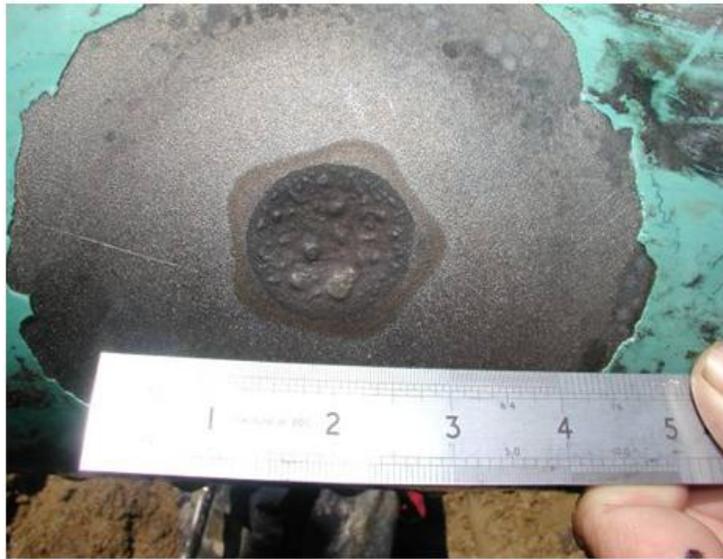
Figure 6. Typical A-C Corrosion Morphology

In recent years corrosion of carbon steel structures has been documented as a result of induced A-C caused by electromagnetic interference in collocated right-of-ways. Corrosion rates of 2.4mm/yr (60mpy) have been documented on pipelines with high quality dielectric coatings. Critical current densities of >20 amperes/m² are necessary for A-C assisted corrosion requiring pinhole defects in coatings to concentrate the current density. An example of the corrosion morphology associated with A-C interference current is shown in Figure 6.

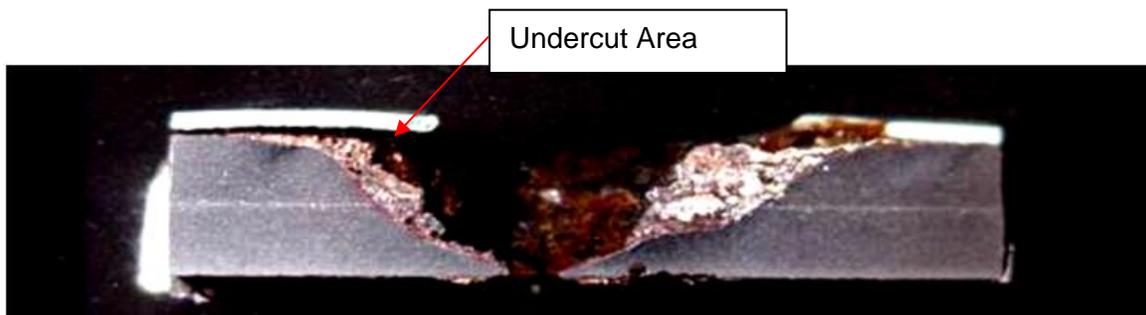
Stray D-C Interference also produces "Dish Shaped" hemispherical pitting, however, corrosion caused by Stray D-C is characterized by an absence of tubercles. Typical pH ranges are less than 2 and thus iron oxides are soluble in these pH environments. The effects of Stray D-C interference corrosion can be seen in the metallographic section shown in Figure 7. This metallographic section obtained from a corrosion leak site on a 4-inch diameter FBE coated pipeline subjected to Stray D-C shows characteristic "undercutting" of the coating to the left.

Figure 7. Metallographic Cross Section – Stray D-C Interference Corrosion (4-inch FBE Coated CS Pipeline)

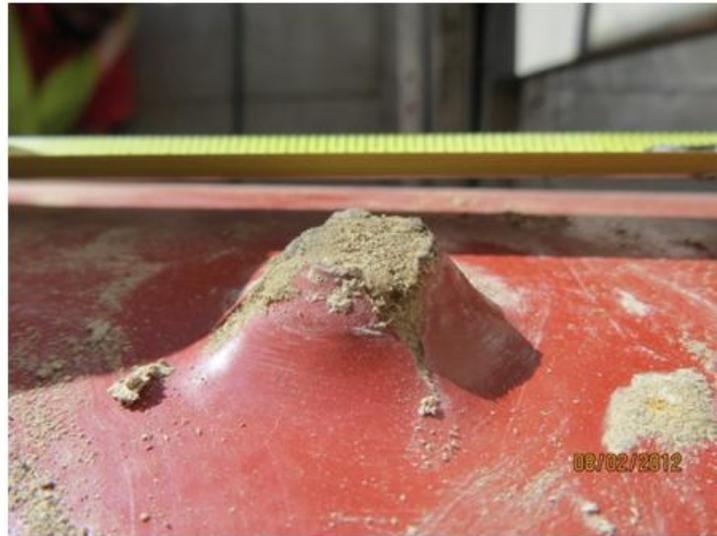
Stray Alternating Current (A-C) corrosion is characterized by oval corrosion features and the build-up of corrosion products at small coating flaws coincident with the pitted area. The growth of the corrosion products typically causes the coating to separate and tent up ("lift-off") from the pipe substrate and is accompanied by cracks in the coating due to the expansive forces of the growth of the corrosion product as shown in Figure 8. The pH values in the pitted are typically range from 6-12 in the presence of cathodic protection which raises the pH, but does not control the corrosion.

Figure 8. A-C Corrosion – FBE Coating “lift-off” and Cracking

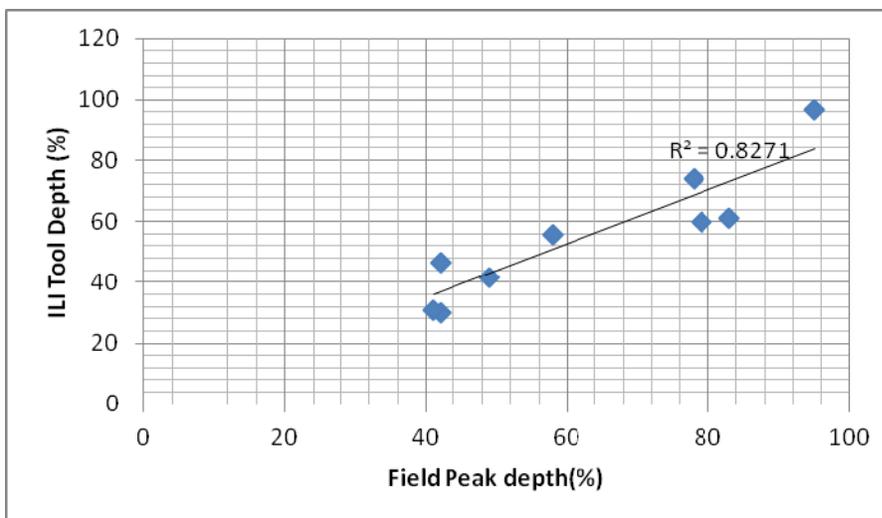
Figure 32. Unity Plot

4. Consider examining a select number of unrepaired ILI external metal loss anomalies six (6) months after implementing any necessary remedial measures to ensure that corrosion growth has been successfully controlled. Although based on a small data set, the unity plot shown in Figure 32 shows reasonable agreement with the ILI tool predicted peak depth and field measured peak depth with the ILI tool appearing slightly conservative. On that basis it would be reasonable to examine a select number of unrepaired ILI detected features to ensure a reduction in corrosion growth.
